A358 Taunton to Southfields Dualling Scheme

Ecological Baseline Report – Barn Owl

HE551508-ARP-EBD-ZZ-RP-LE-000009

24 May 2022

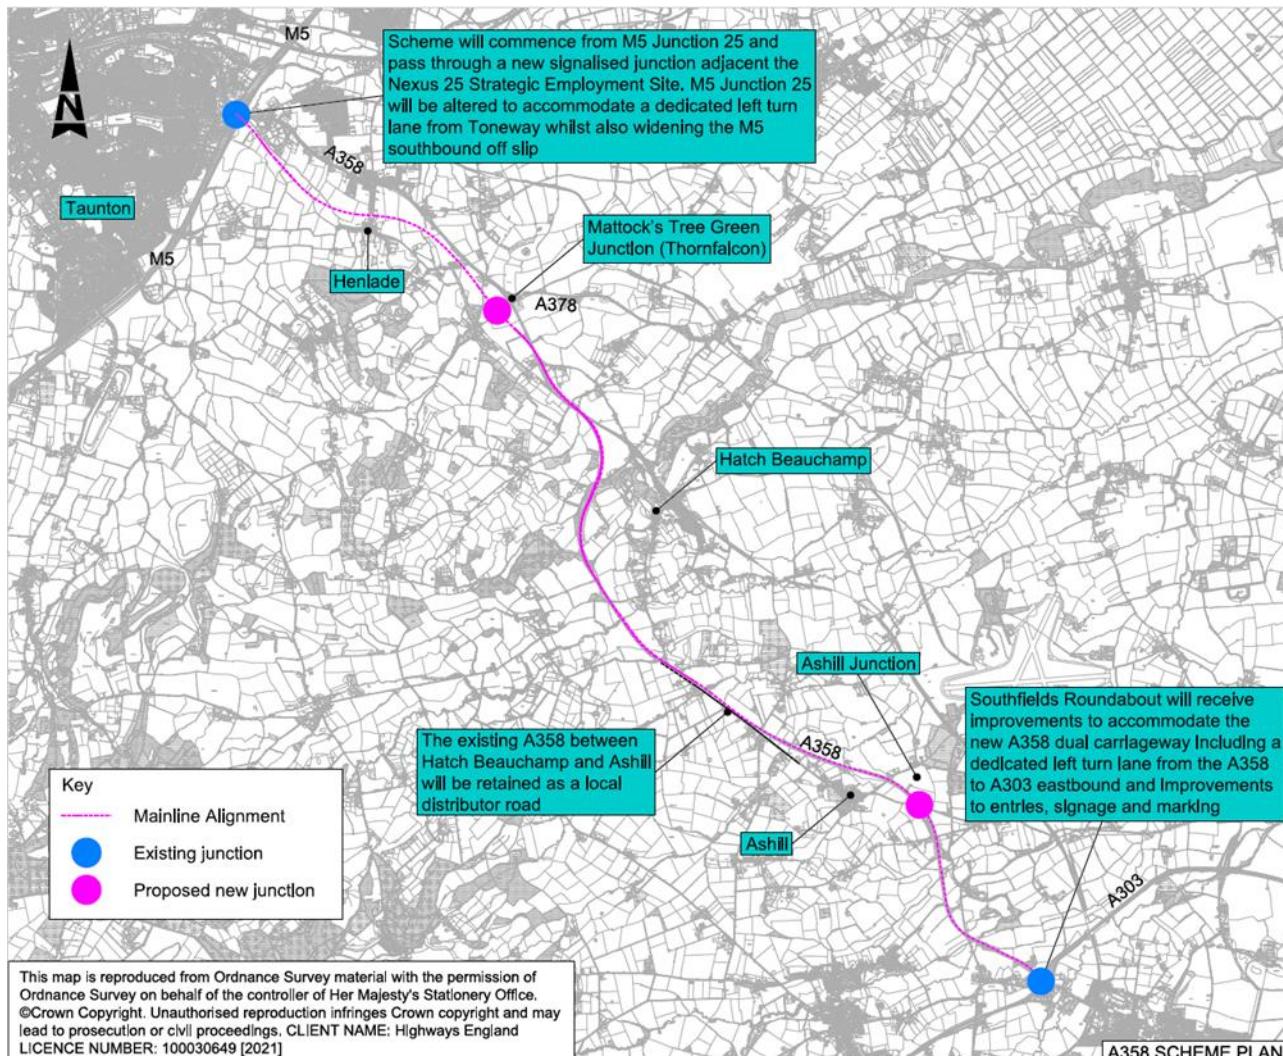
Figure 1-1 Scheme plan

- 1.2.3 The scheme directly addresses this long-term commitment and would provide a new rural all-purpose dual carriageway link from the M5 at Taunton to the A303 at Southfields roundabout. The new dual carriageway would comprise new and upgraded stretches of the existing A358 road. Full details of the scheme will be provided in Chapter 2 *The Project* of the Environmental Statement (ES). Please refer to Figure 1-1 for scheme plan.

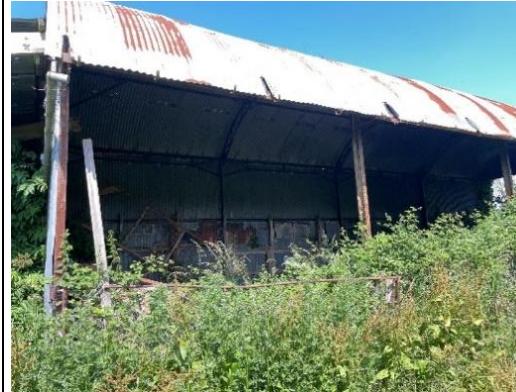
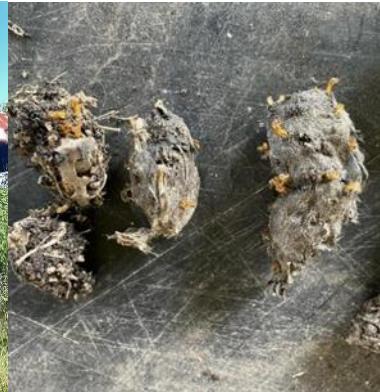
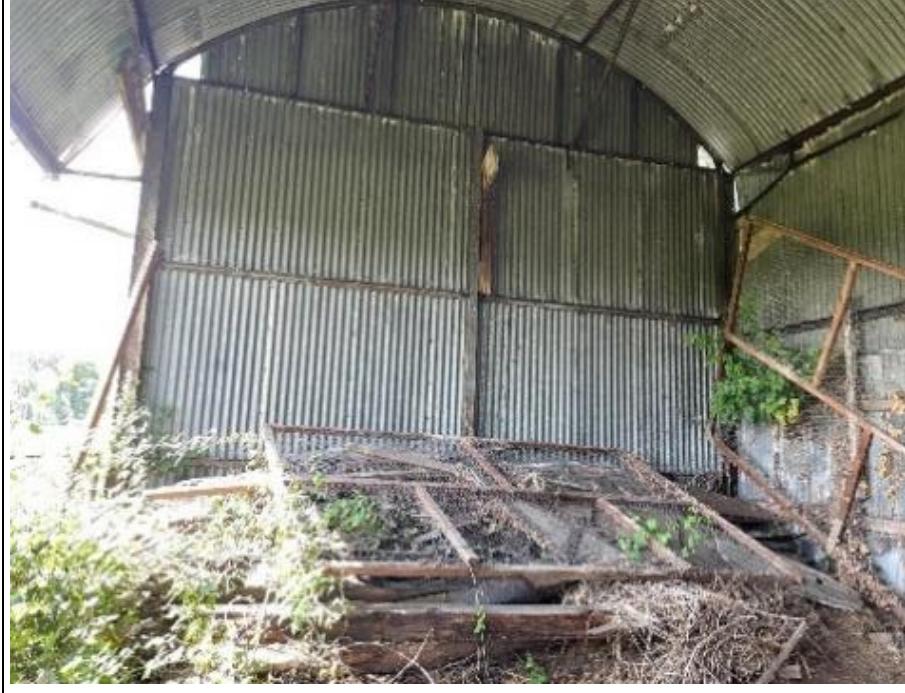
Feature	Type	Description	Date surveyed	Photos
ARS6	Dutch barn located west of Haydon.	<p>Open Dutch barn with limited agricultural use indicated by piles of debris. No nesting opportunities but posts at 4m height offer perching points.</p> <p>Nineteen visible pellets, mostly atop debris pile at southern end of barn below roost perch. Pellets varying in age from several weeks old to several years, potential for many more to have fallen through debris pile. Whitewash present on and below perching point.</p>	01/07/2021

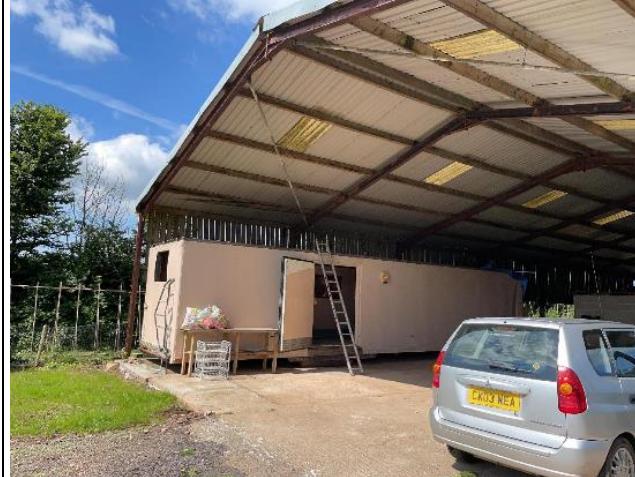
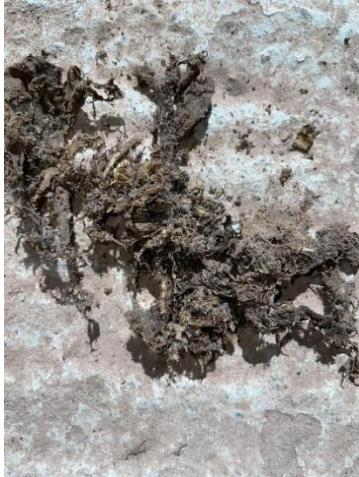
Feature	Type	Description	Date surveyed	Photos
ARS7	Large modern barn complex	<p>A single degraded pellet (several years) was found on top of a container roof. Landowner described pellets perfectly and claims to have swept up such evidence on a regular basis. Kestrel pellet also found.</p> <p>Metal beam at front of barn is the only suitable roosting location.</p>	14/07/2021

- ARS7 is an extensive metal barn utilised as a workshop and for keeping fowl. A single metal beam offers roosting opportunity. The landowner reported regular pellets beneath the beam and a single highly degraded pellet (30+ months) was recovered from the roof of a container beneath this beam, preventing it from being swept away.

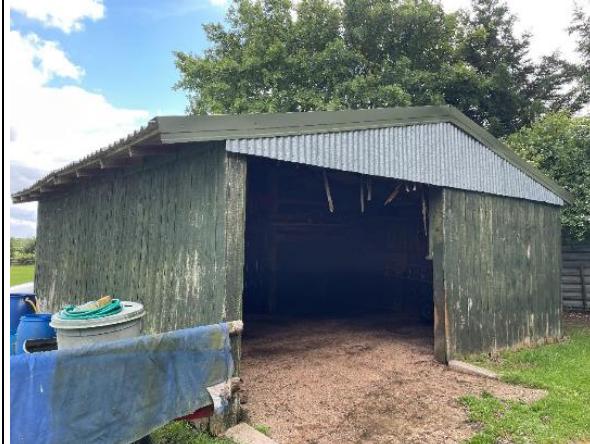
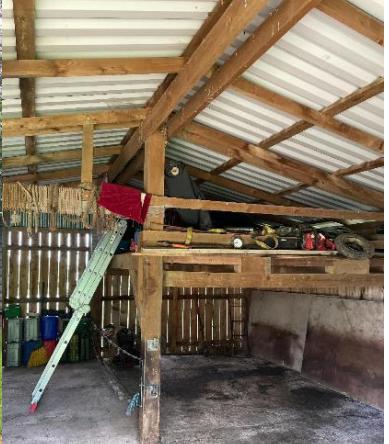
ARS8	Corrugated metal workshop	<p>Open-fronted barn with mezzanine.</p> <p>Landowners claim to have seen barn owls using the barn, and accurately described pellets and whitewash, which was cleaned prior to the survey. Low wooded beams offer suitable perches for roosting only.</p>	22/06/2021

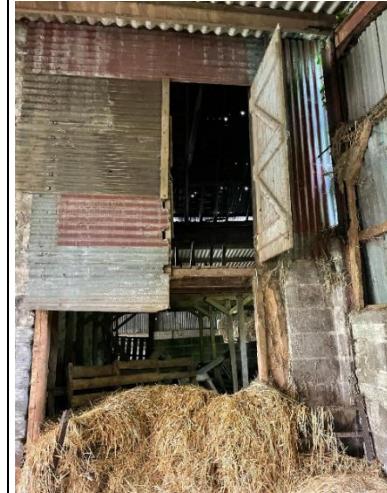
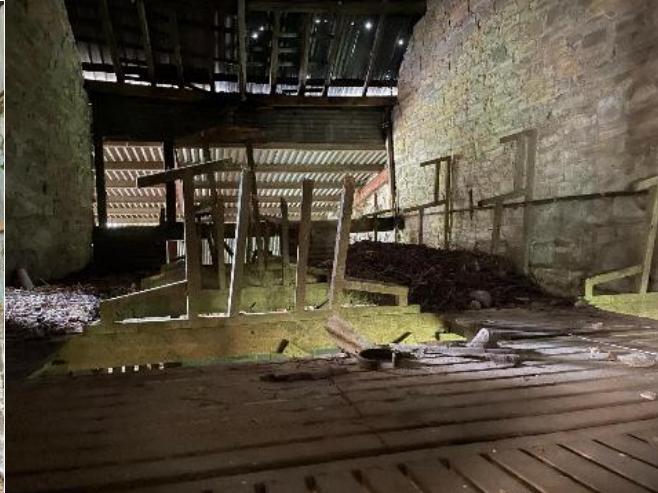
Feature	Type	Description	Date surveyed	Photos
ARS9	Derelict barn	<p>Set of stone barns in some disrepair, previously used for storage, now seemingly unused. Lots of beams for roosting, several with pellets beneath. Only possible nesting location is on the floor of the upper level, approximately 2 metres from the ground. However, somewhat exposed and appears to be historically used by jackdaw.</p> <p>Eight pellets were identified all in various stages of disintegration (approximately one month old to several years). An unidentifiable chick carcass, likely jackdaw, was also identified indicating a previous nesting attempt by this species.</p>	29/06/2021

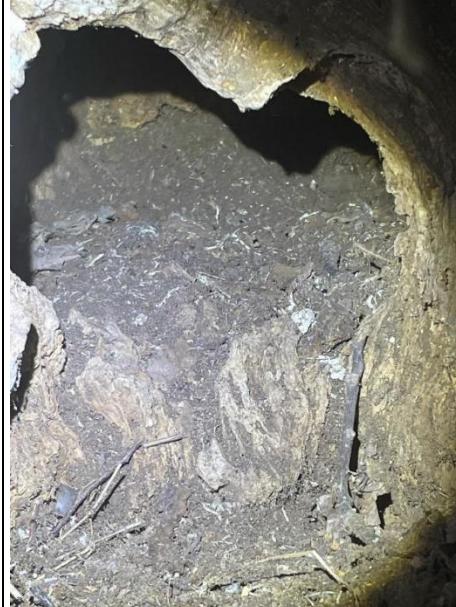
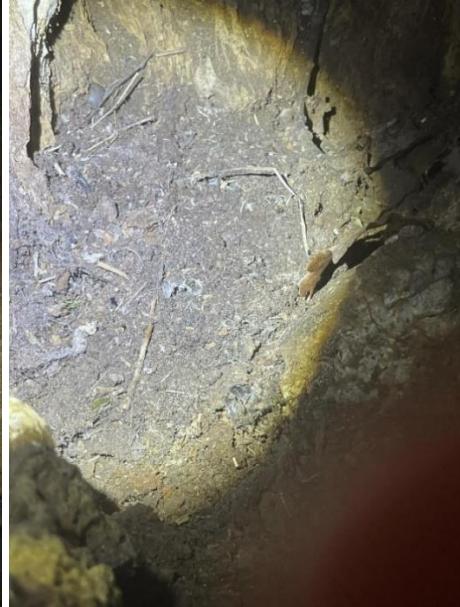
Feature	Type	Description	Date surveyed	Photos
TRS2/ potential historic nest site	Extensive cavity in oak	<p>Large dry cavity in main trunk of pollarded standard oak in cattle grazed field.</p> <p>Numerous small mammal bones within cavity debris indicating historic use by barn owl, possible shredded pellet material indicative of a historic nesting attempt.</p>	14/07/2021

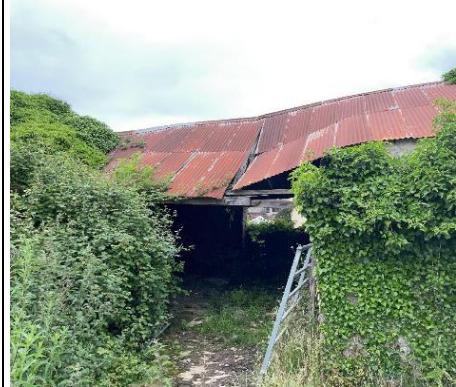
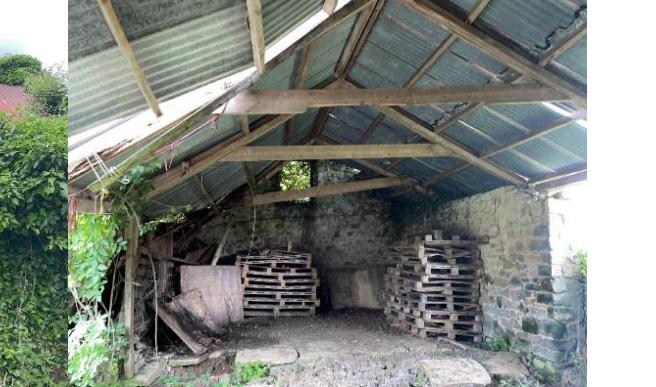
TRS3	Derelict cattle shelter	<p>No nesting opportunities but cross beams provide suitable roosting features. Both landowner and neighbours report seeing barn owl using the structure for roosting, although not recently. Any historic evidence likely to have been trampled by cattle.</p>	29/06/2021

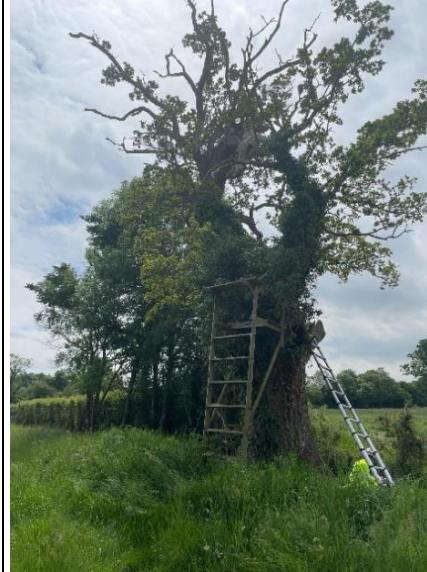
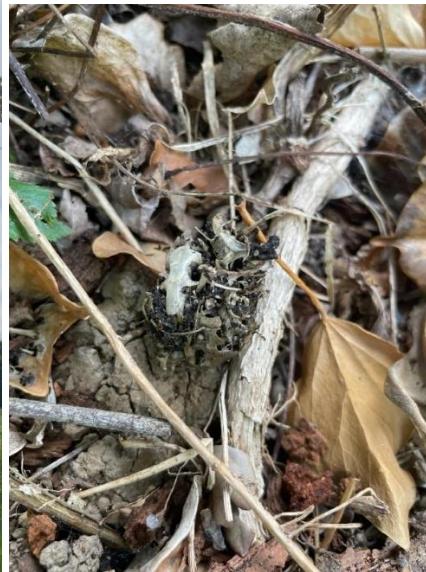
Feature	Type	Description	Date surveyed	Photos
TRS4	Pedunculate oak with multiple cavities, located in Jordan's Park, north of Ilminster.	<p>Three entrances around 4m high all checked – none extending far enough to constitute a PNS.</p> <p>Four highly degraded barn owl pellets and two kestrel pellets under north-facing limb. Whitewash also present. Twisted limb at 10m could not be checked.</p>	09/06/2021

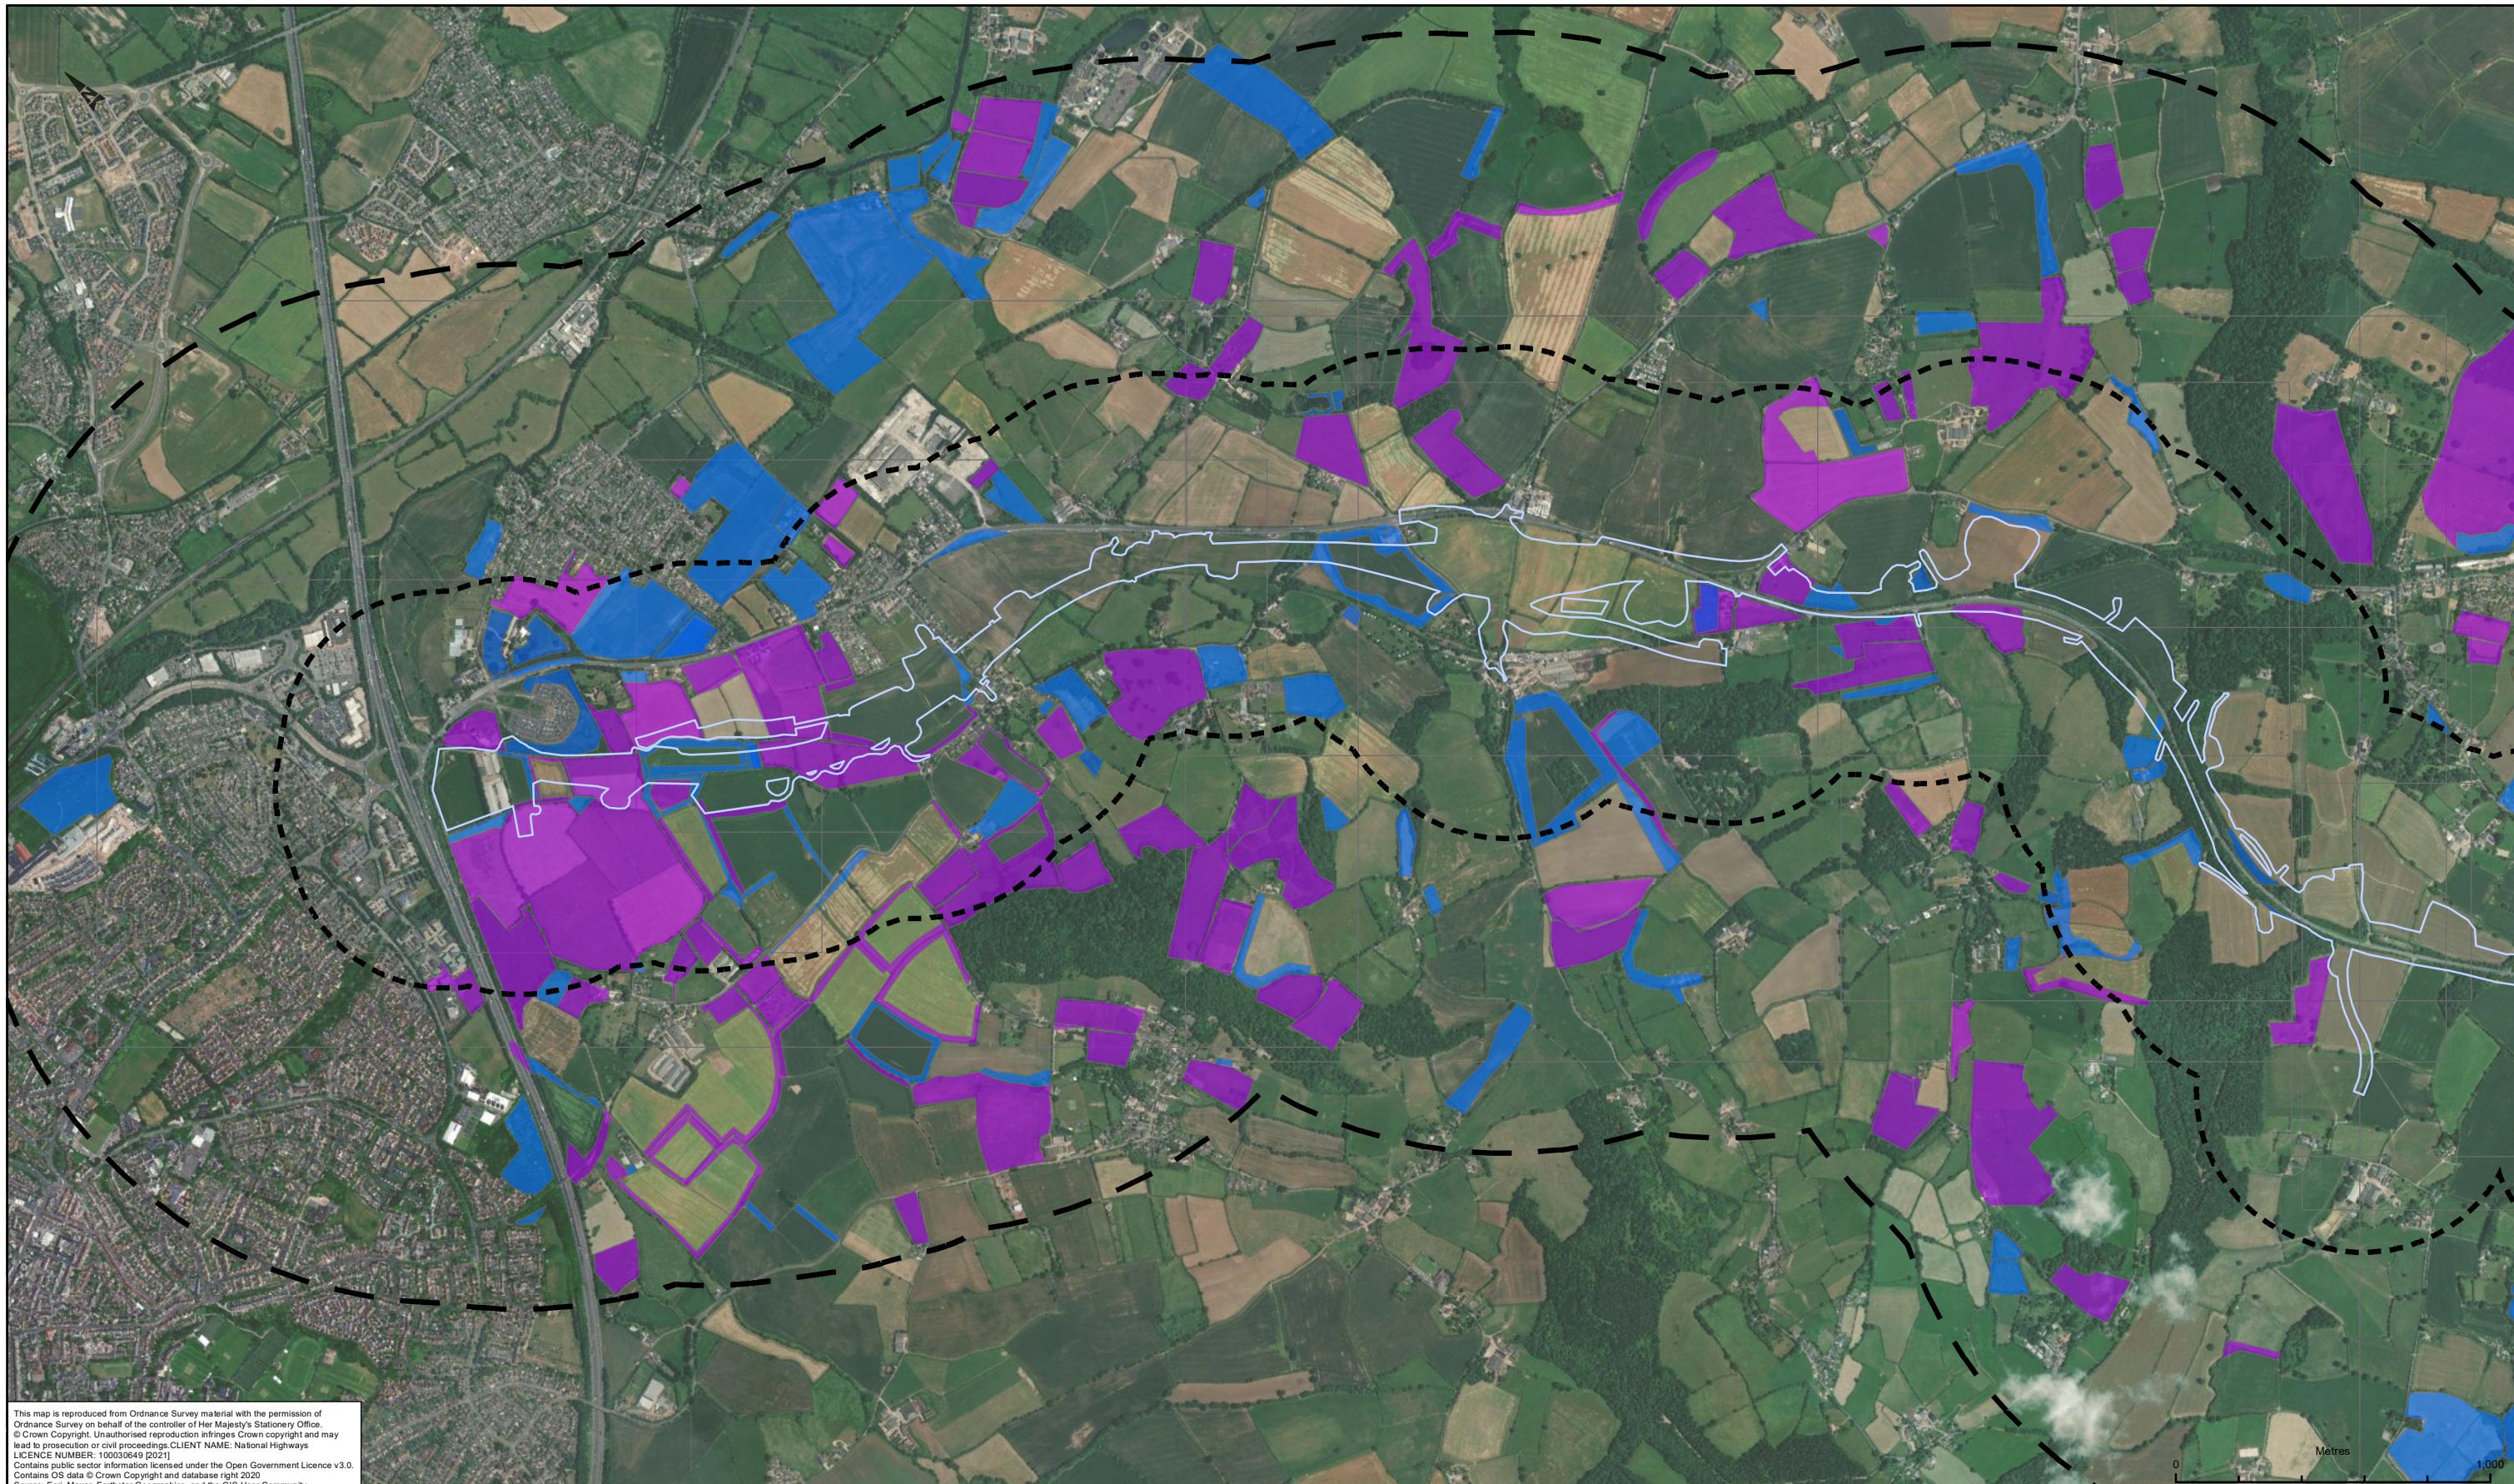
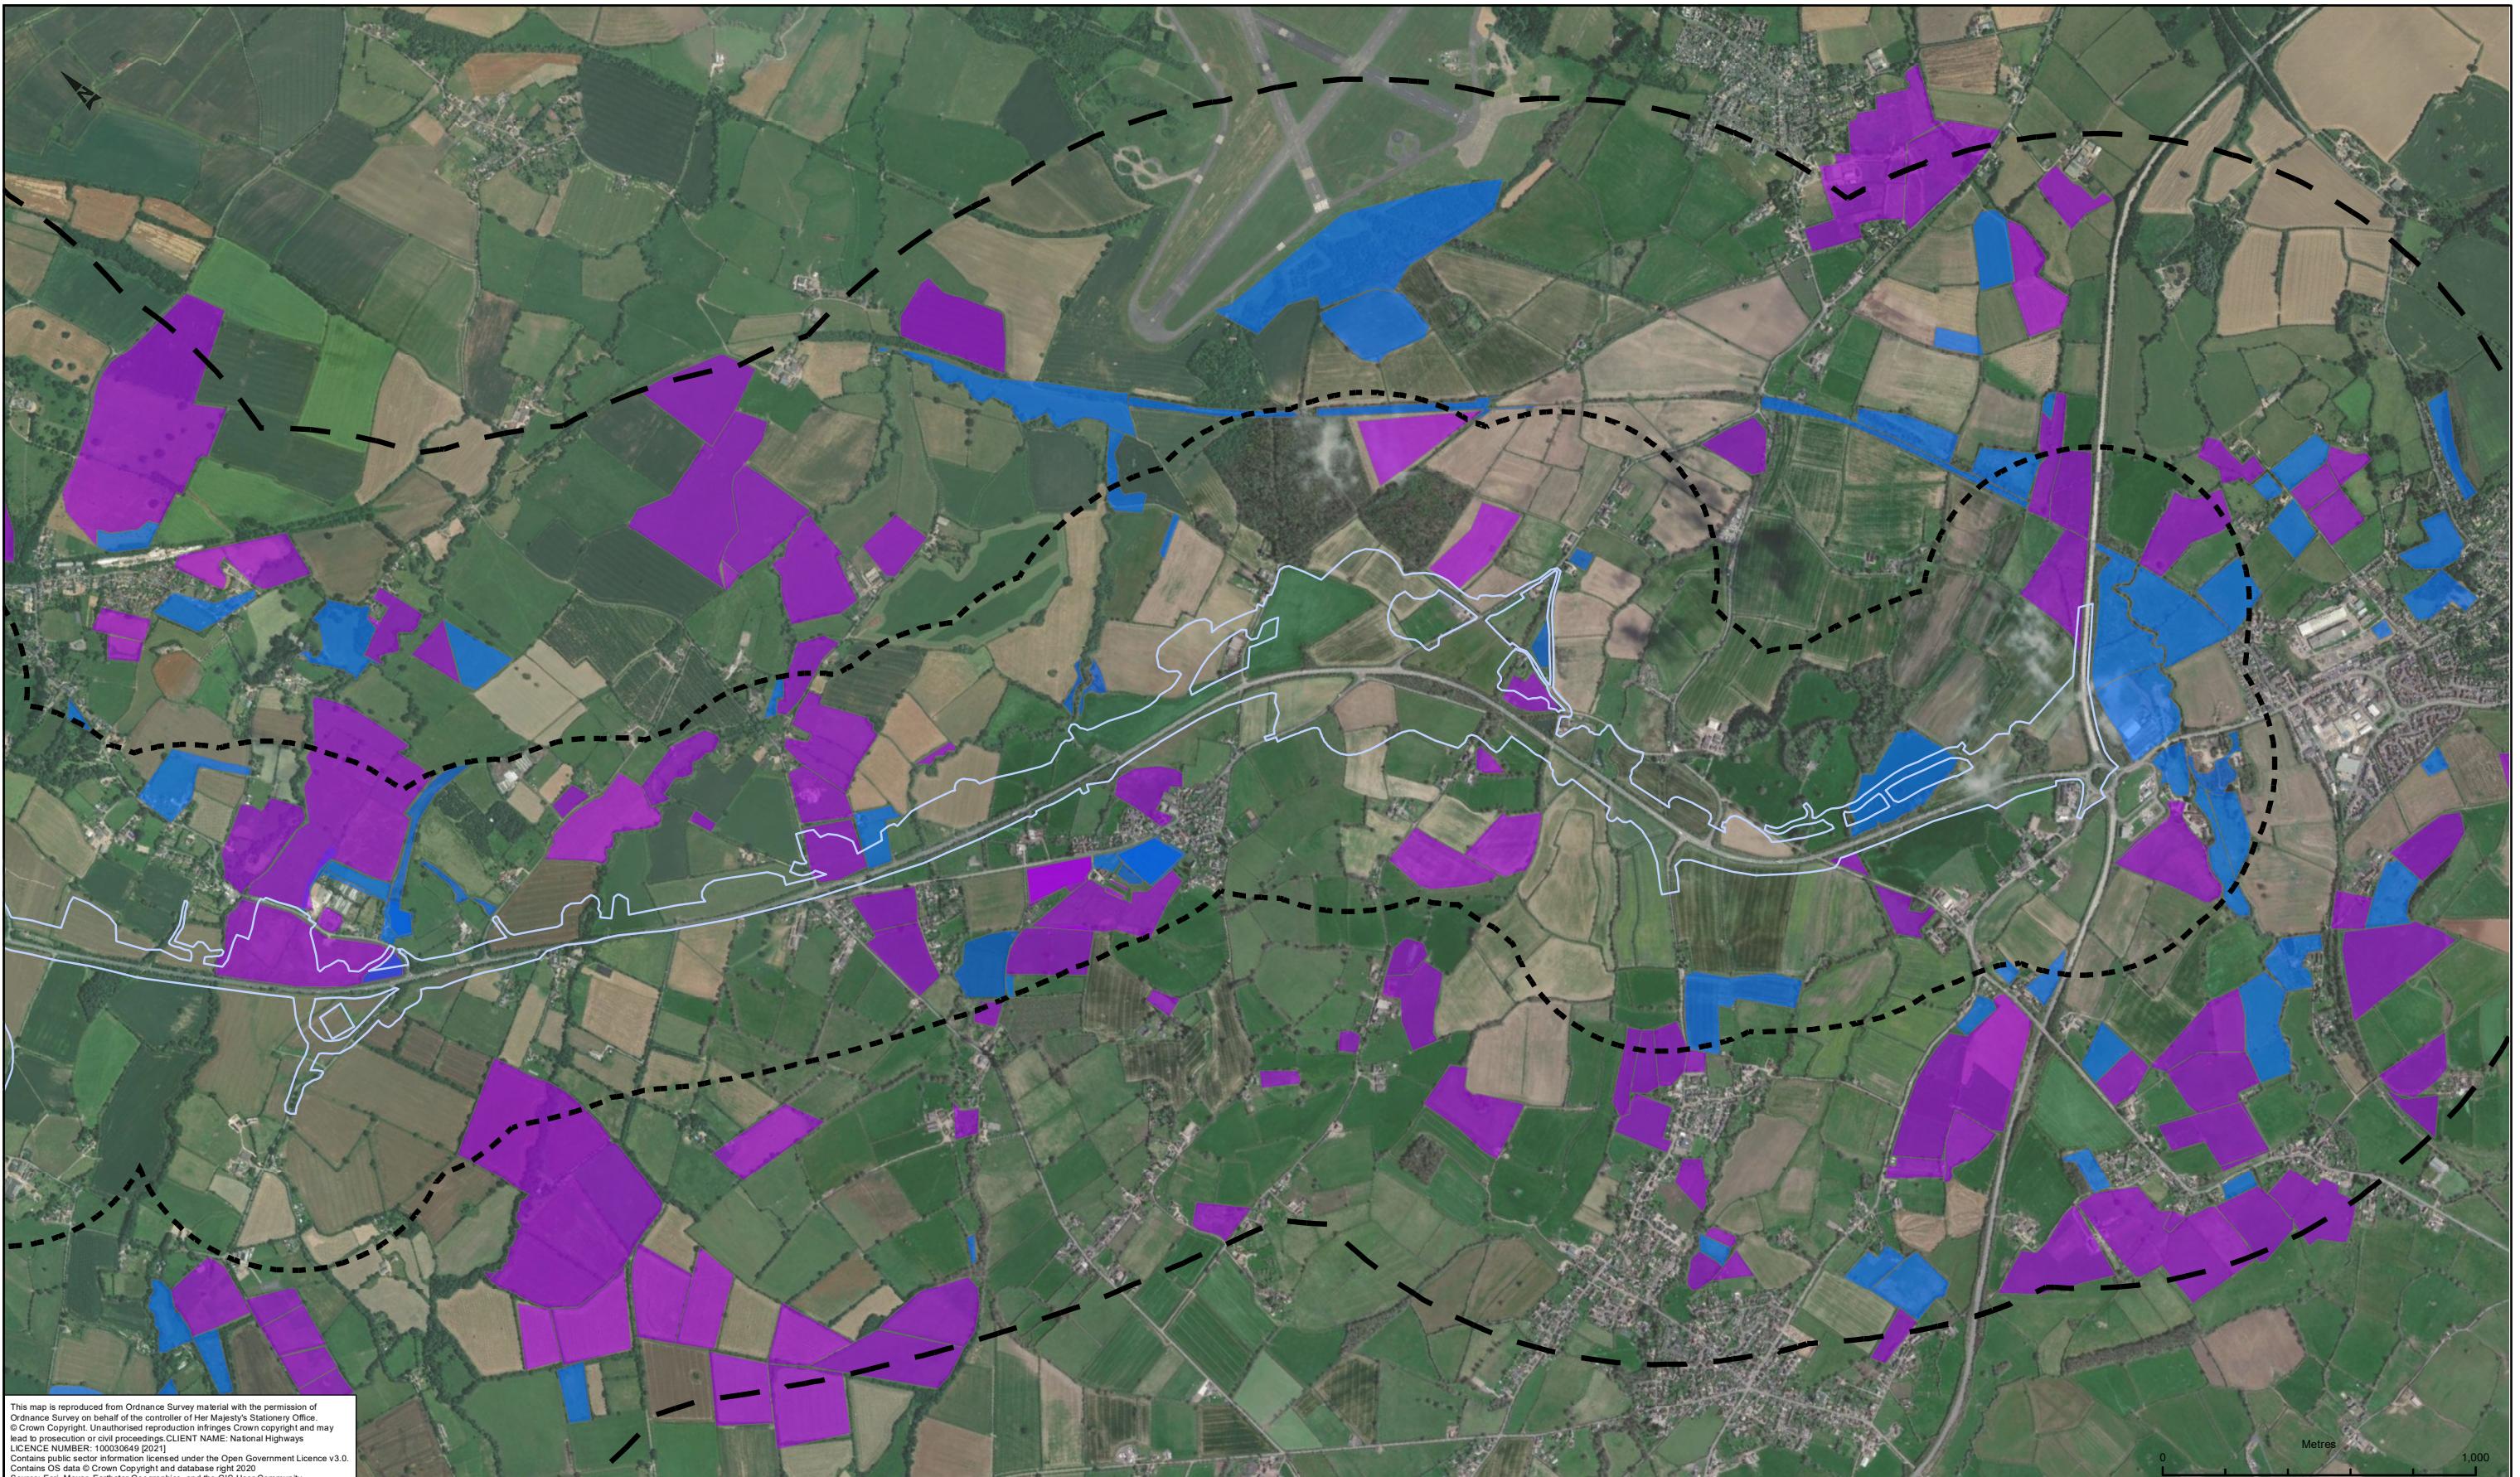
Figure A-1 Location and extent of type 1 and type 2 habitat

TYPE 1 - PERMANENT, HIGH QUALITY TUSSOCKY
GRASSLAND WITH THICK LITTER LAYER

TYPE 2 - SUBOPTIMAL FORAGING HABITAT (TRANSIENT
GRASSLAND, OPEN SCRUB)

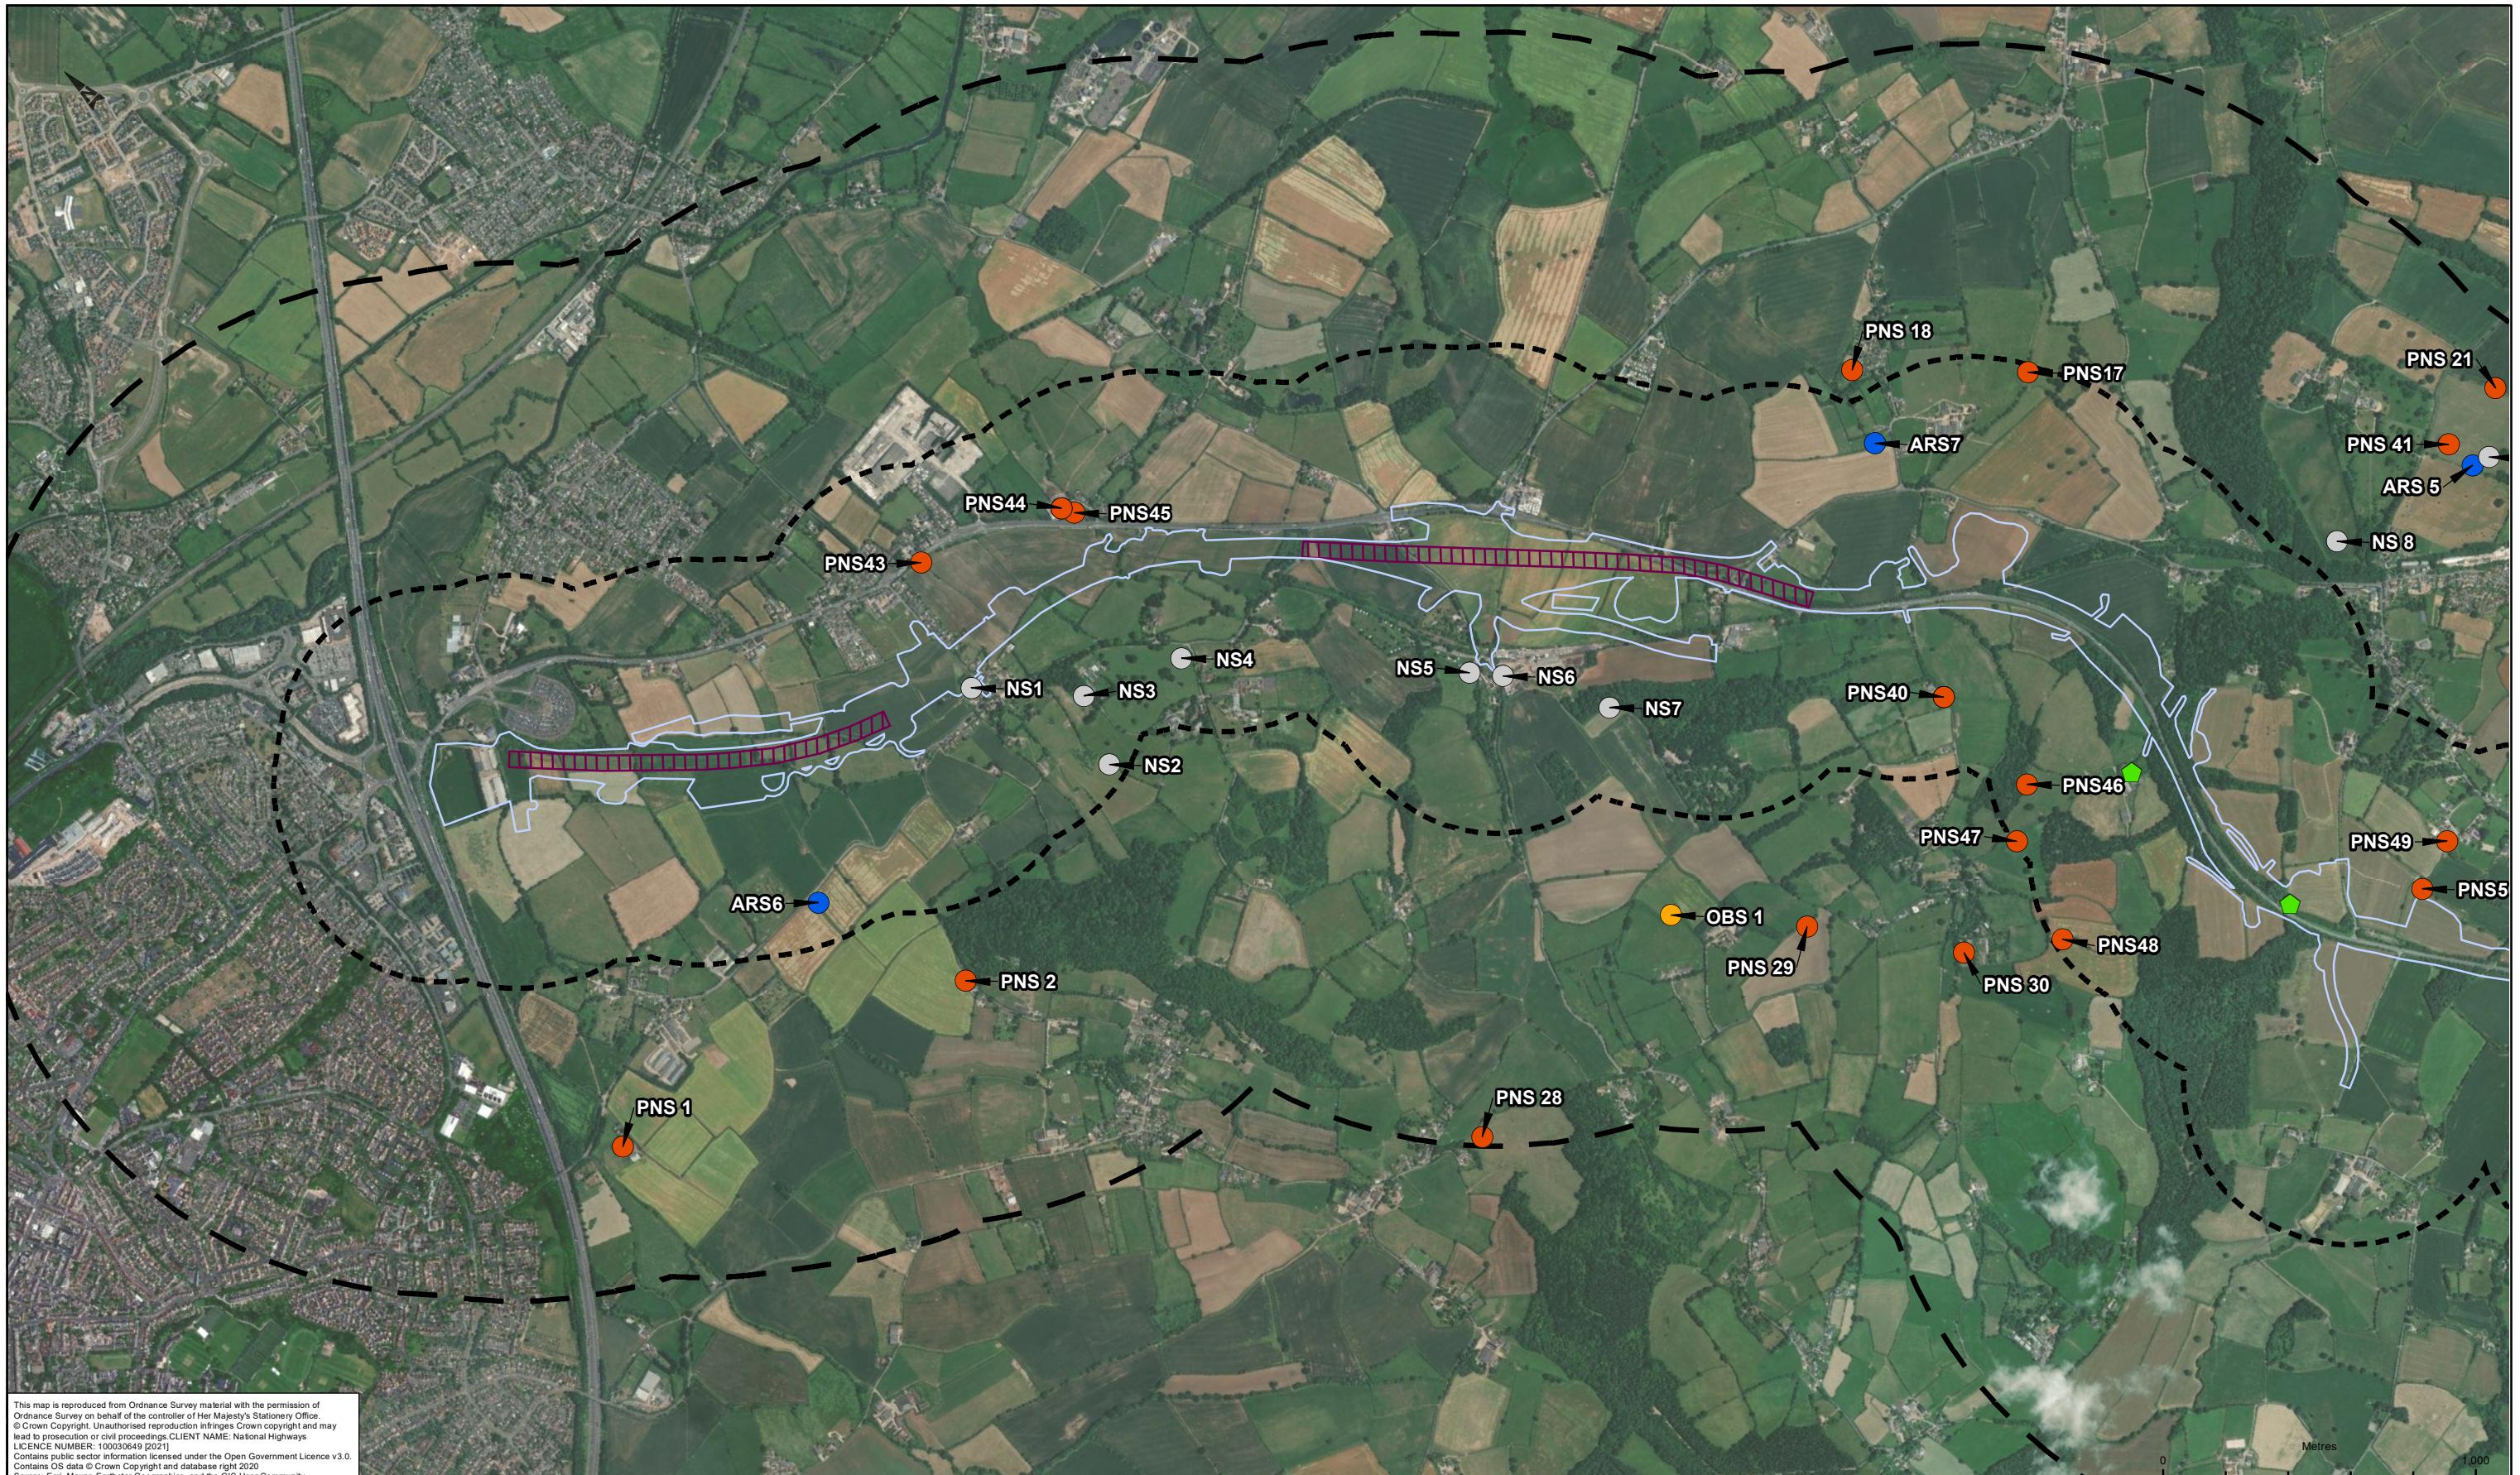
Figure B-1 Barn owl nesting plan (locations of PNS, ARS, TRS), potential TABs and incidental barn owl records

- 3.2.15 A dead barn owl was noted adjacent to the A358 carriageway on the 2 September 2021 at Capland, shown in Figure B-1, Appendix B Stage 2 and 3 field survey results. Whilst it was not possible to recover the corpse for safety reasons, given the location and timing, this was likely to be a dispersing juvenile bird that had died as the result of a traffic collision. It is notable that there are large patches of type 2 foraging habitat, interspersed with type 1, immediately north of this location, including a patch of type 1 immediately adjacent to the location. A barn owl pellet was anecdotally recorded beneath a tree without a cavity just north of this location, also in September 2021. Roosting in trees without cavities is characteristic of dispersing juveniles [5] and further supports the likelihood of the deceased bird being a juvenile. This area was consequently classified as a TAB.

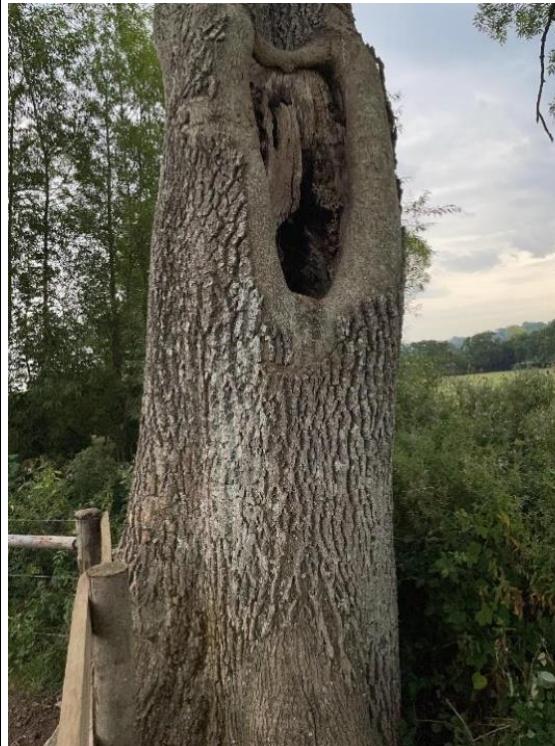
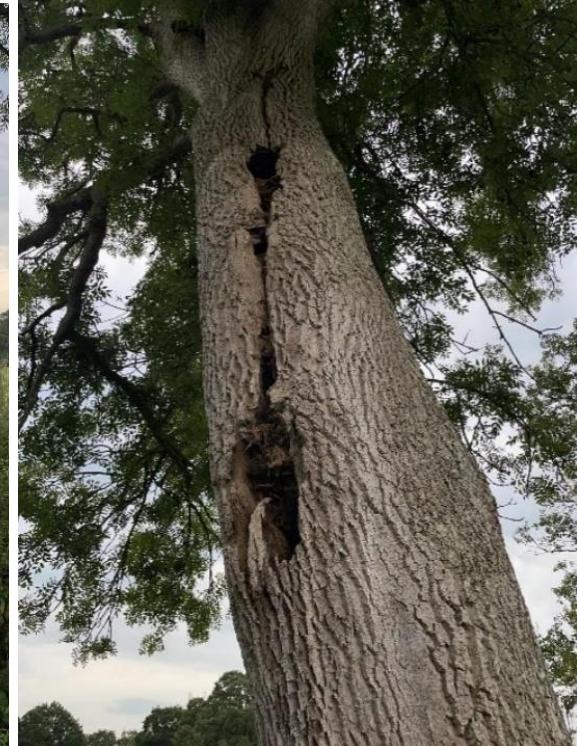
Feature	Type	Description	Date surveyed	Photos	
PNS17	Mature ash trees with multiple cavities.	<p>Mature ash in riparian corridor with several cavities in largely hollow trunk.</p> <p>Lower cavity at 2.5m extends down to base of tree, no evidence identified. Trunk higher up appears to be hollow, visible through cracked bark on NW side. Unable to safely inspect cracks, but appear to be full of packed debris, indicating jackdaw nesting attempt. Precautionarily classified as PNS.</p> <p>Kestrel feathers and pellets also found at the base of tree.</p>	08/09/2021

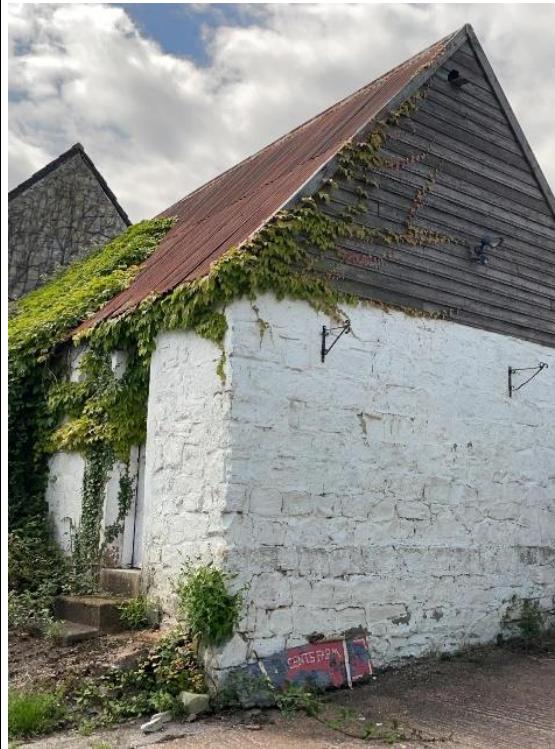
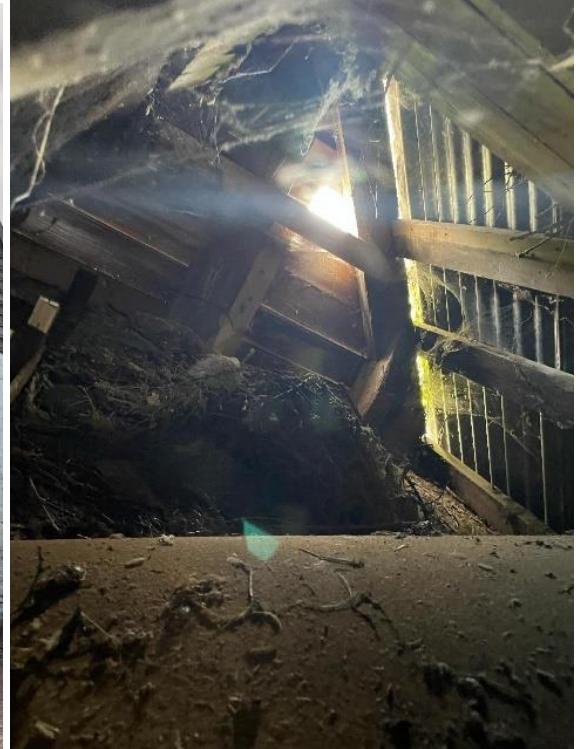
Feature	Type	Description	Date surveyed	Photos
PNS40	Purpose built cavity in barn	<p>Roof void of storage barn attached to main residential property. Void purpose built for barn owl, with entrance on the north facing gable. Has not been maintained and is somewhat dilapidated but still functioning.</p> <p>Piled nesting material indicates historic use by jackdaw.</p>	13/07/2021

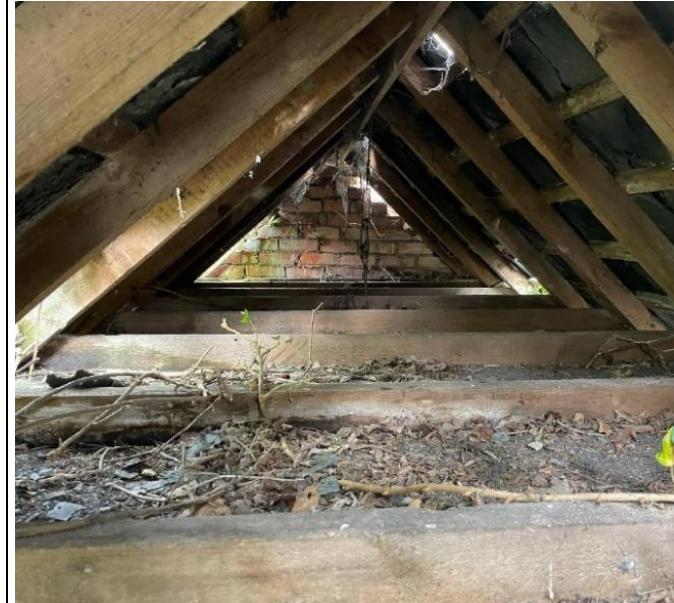
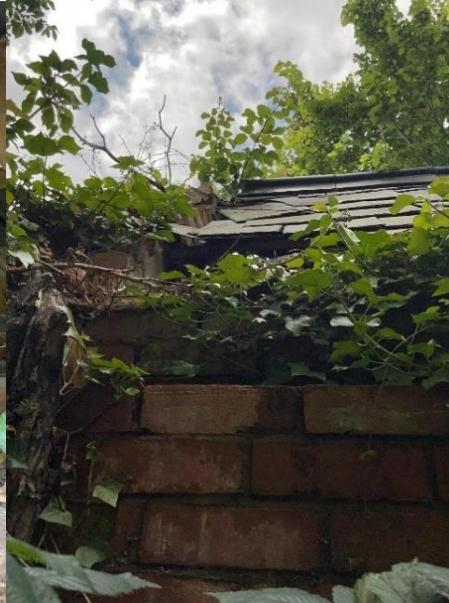
Feature	Type	Description	Date surveyed	Photos
PNS43	Small abandoned storage shed	<p>In field corner, now largely overgrown but still structurally sound.</p> <p>Roof void is suitable for nesting with entrance through large gaps in tiles at one end. Entrance partially obscured by vegetation at time of survey.</p> <p>No evidence of use by any species identified.</p>	13/07/2021

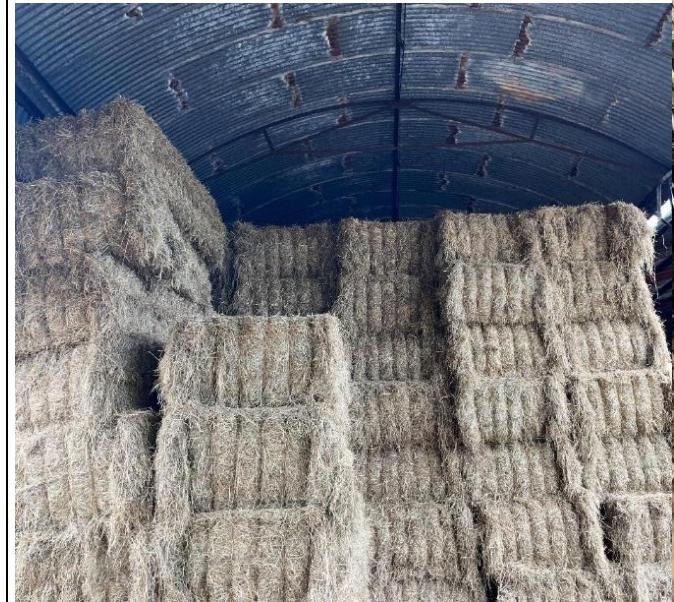
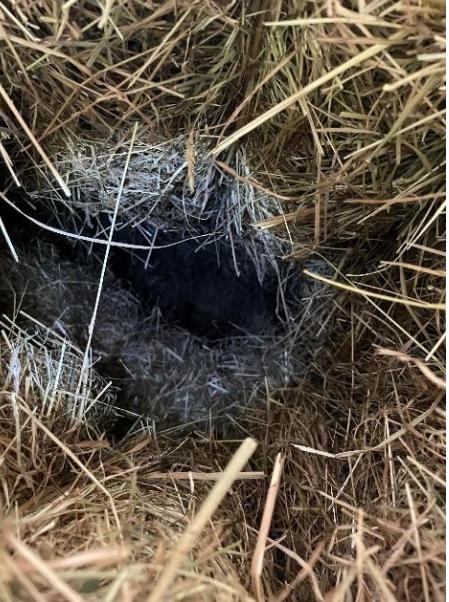
PNS44	Gaps in stacked hay bales in Dutch barn	<p>Stacked hay bales in Dutch barn complex, with lots of cavities and depressions amongst bales offering suitable protection, all thoroughly checked.</p> <p>Landowner not present, so unable to determine the permanence of hay bales within the barn.</p>	13/07/2021

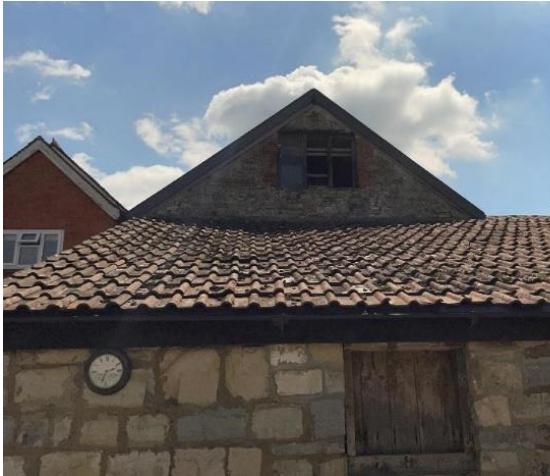
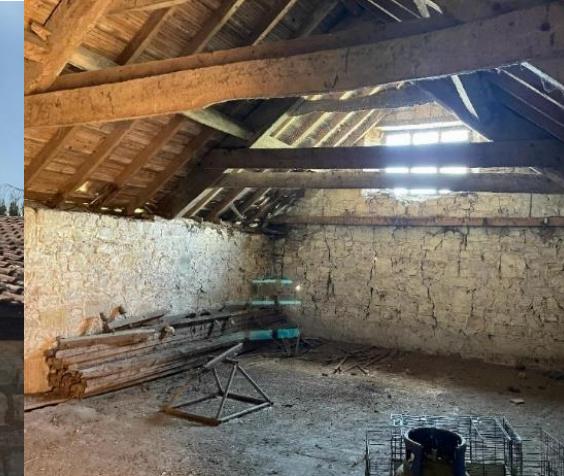
Feature	Type	Description	Date surveyed	Photos
PNS45	Unused work shed	<p>Large open space in seemingly disused work shed in farmyard. Access through window panes with no glass.</p> <p>Wooden beams offer suitable perching points but nesting opportunities are limited to floor of the room, amongst old debris on the floor.</p>	13/07/2021

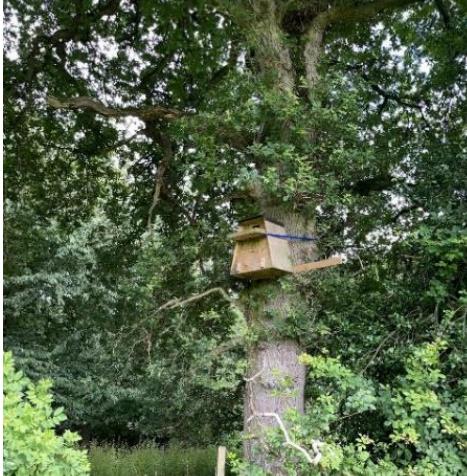
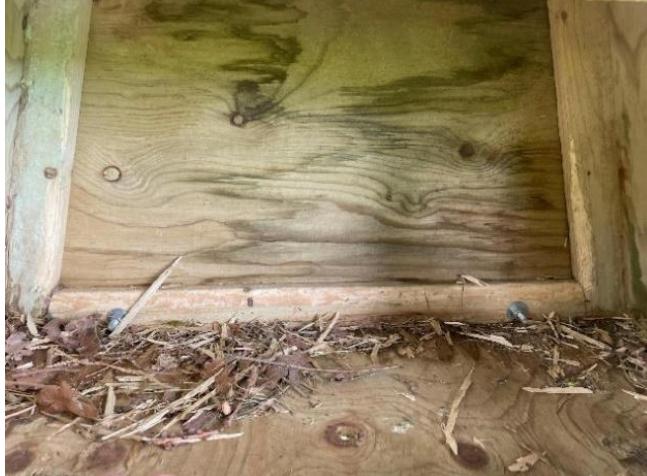
PNS46	Purpose built nest box on oak tree	<p>Wooden nest box on oak on the edge of a woodland, facing open grazing land to the south. Looks to be in good condition and relatively newly installed.</p> <p>Stripped wood from inside box indicates use by grey squirrel.</p>	13/07/2021
