A358 Taunton to Southfields Dualling Scheme

Ecological Baseline Report – Barn Owl

HE551508-ARP-EBD-ZZ-RP-LE-000009

24 May 2022

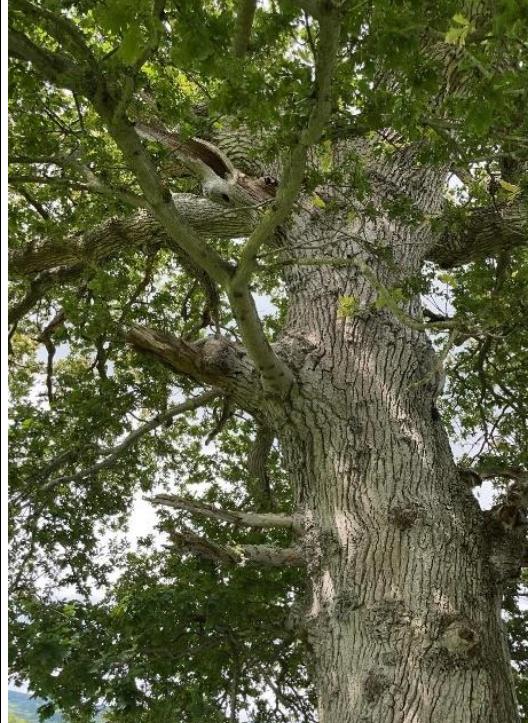
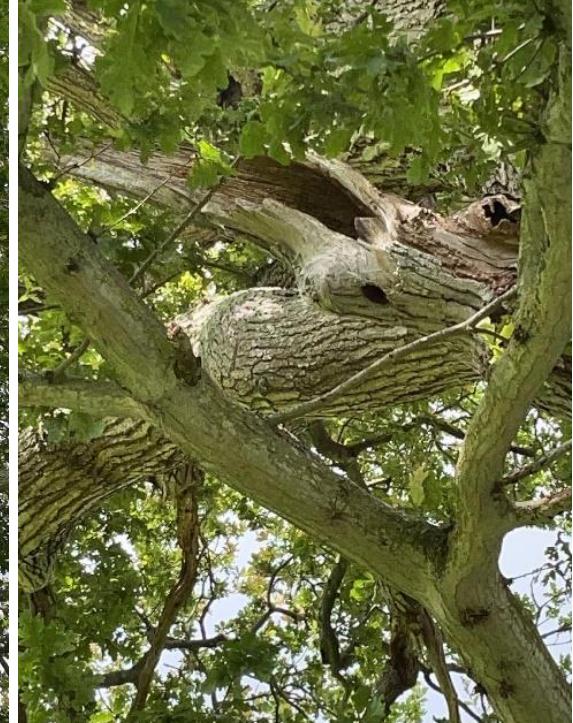
Feature	Type	Description	Date surveyed	Photos	
PNS47	Cracked limb on standard oak tree	<p>Large cracked-off limb within branch of a mature oak in cattle-grazed pasture.</p> <p>Feature too high to be safely checked, but appears to lead into a substantial cavity, possibly extending into the main trunk.</p> <p>Trampling by cattle around the base of the tree would obscure any evidence if present.</p>	13/07/2021

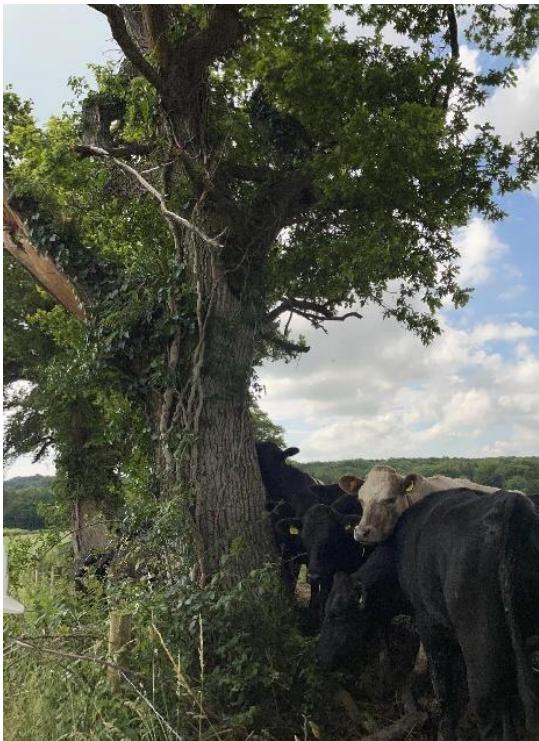
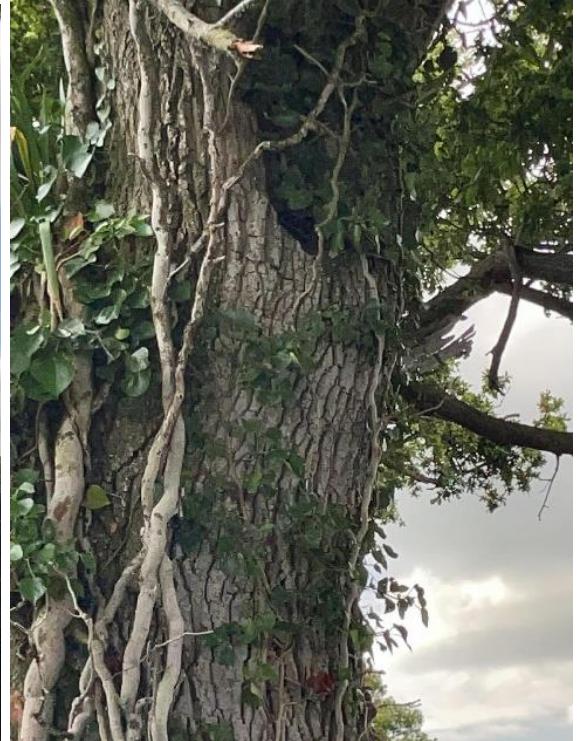
Feature	Type	Description	Date surveyed	Photos	
PNS48	Cavity in trunk of standard oak tree	<p>Mature hedgerow oak with cavity facing north. Entrance partially obscured by foliage and ivy, but large enough for access.</p> <p>Trampling by cattle around the base of the tree would obscure any evidence if present.</p>	13/07/2021

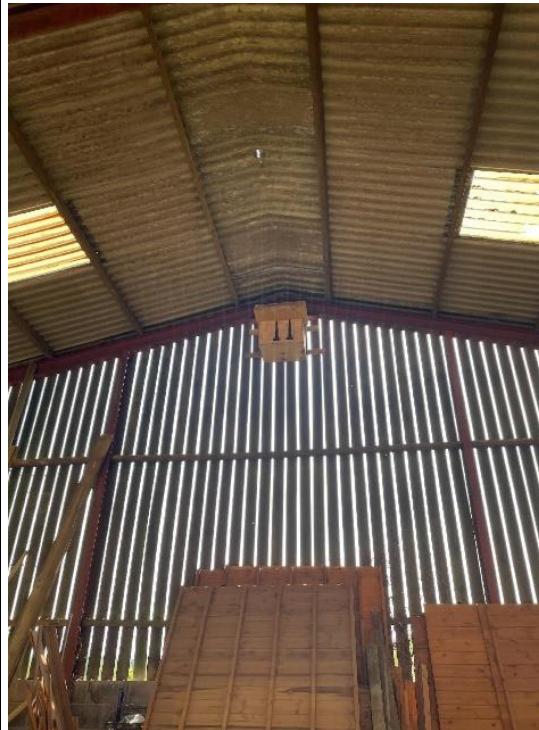
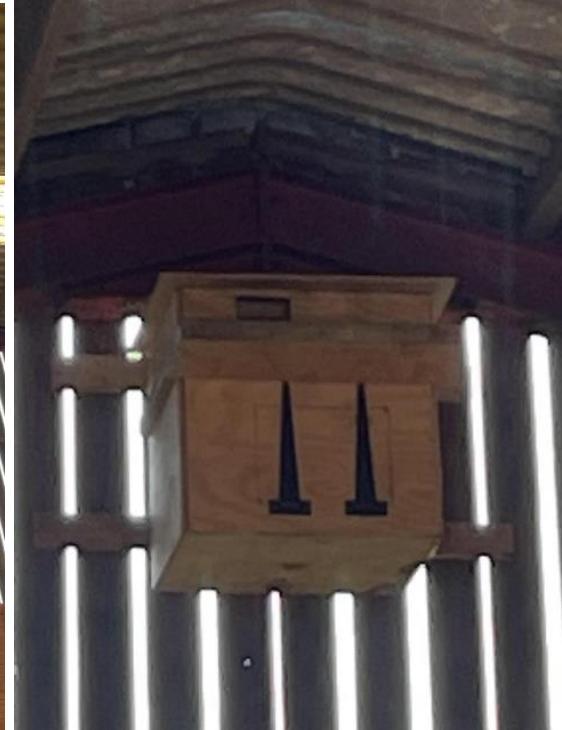
Feature	Type	Description	Date surveyed	Photos
PNS49	Purpose built nest box in modern agricultural building	<p>Recently erected wooden nest box in good condition.</p> <p>Unable to undertake internal inspection as feature is at approximately 9m. Landowner reports box has not been used since erection.</p>	23/06/2021

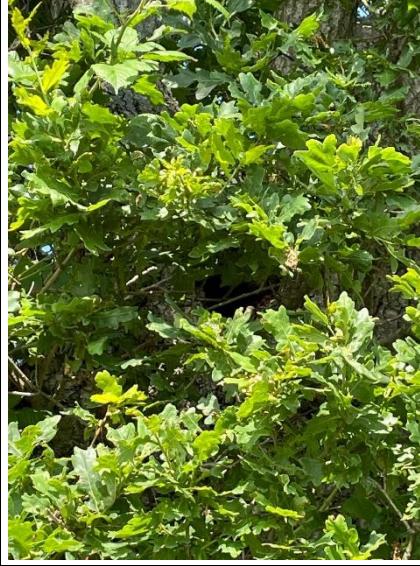
Feature	Type	Description	Date surveyed	Photos
PNS50	Cavity in trunk of an oak tree	<p>South facing cavity in forked trunk of mature hedgerow oak.</p> <p>Entrance hole and internal cavity of suitable dimensions for nesting, but highly obscured entrance reduces suitability for use by barn owl.</p>	23/06/2021

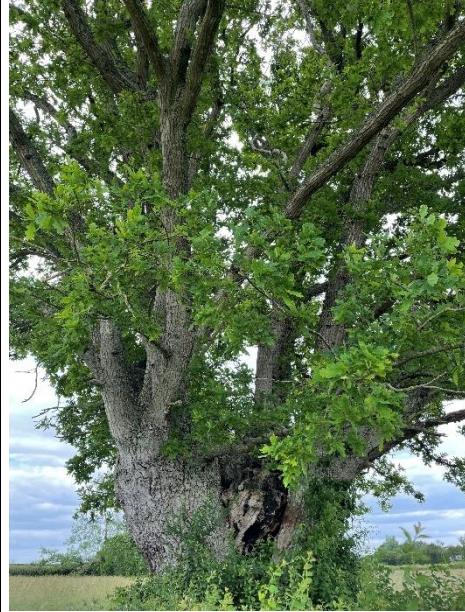
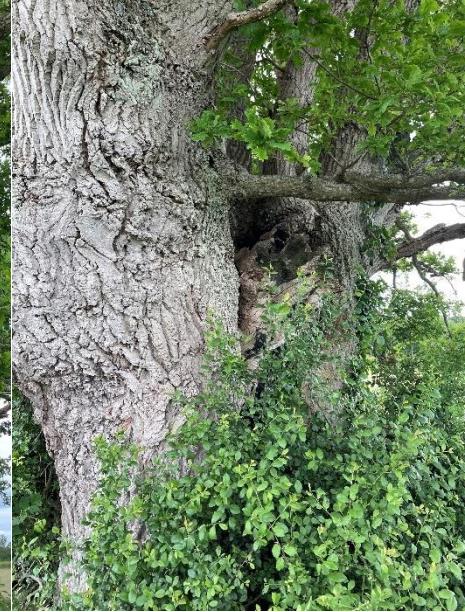
PNS51	Cracked branch with scarring on pollarded oak tree	<p>Potential cavity behind cracked branch.</p> <p>Unable to safely inspect cavity with ladders due to ditch and barbed wire fence at base of tree. Precautionarily classified as PNS.</p>	22/06/2021

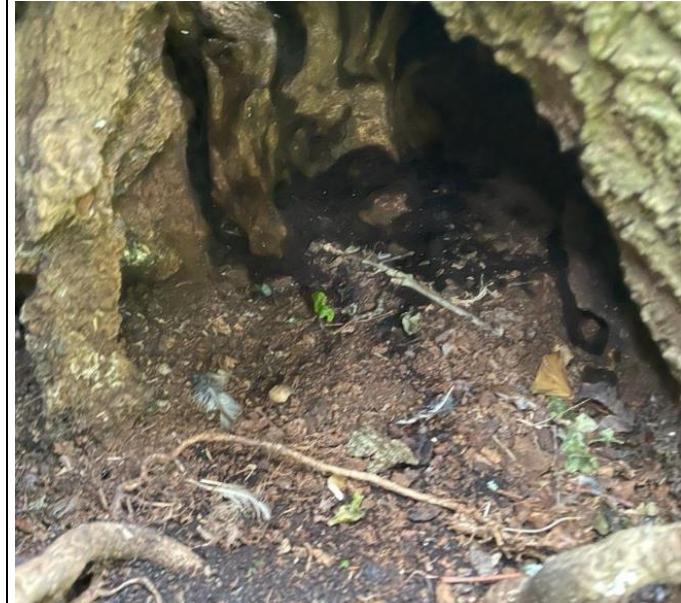
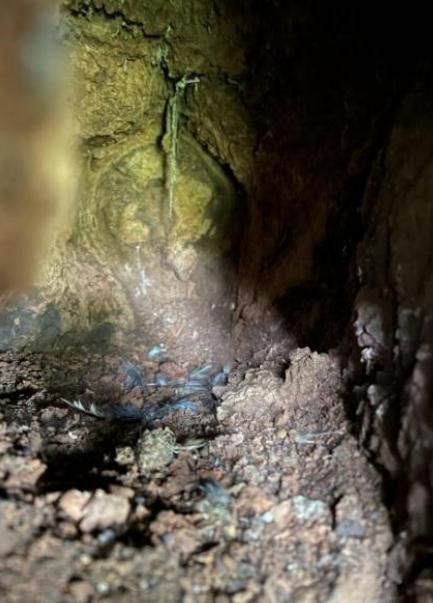
Feature	Type	Description	Date surveyed	Photos
PNS52	Cavities within limbs of oak tree	<p>Two cavities within the bases of large limbs of largely hollow hedgerow oak.</p> <p>Both cavities of suitable dimensions for barn owl nesting and are dry inside.</p> <p>Little owl pellets and feather identified, indicating a roost.</p>	22/06/2021

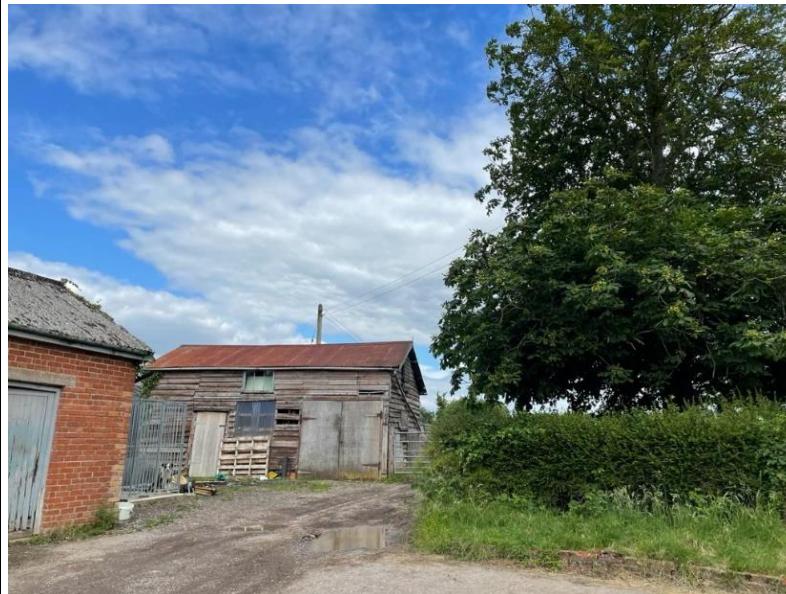
PNS53	Timber clad barn	<p>Broken timber cladding offering access to main barn. Ventilation hole offering access to roof void, which is sealed off.</p> <p>Building locked at time of survey, interior viewed through window. droppings visible.</p> <p>Bat dusk emergence survey in June did</p>	22/06/2021 (with dusk emergence survey using infrared cameras on 25/06/2021)

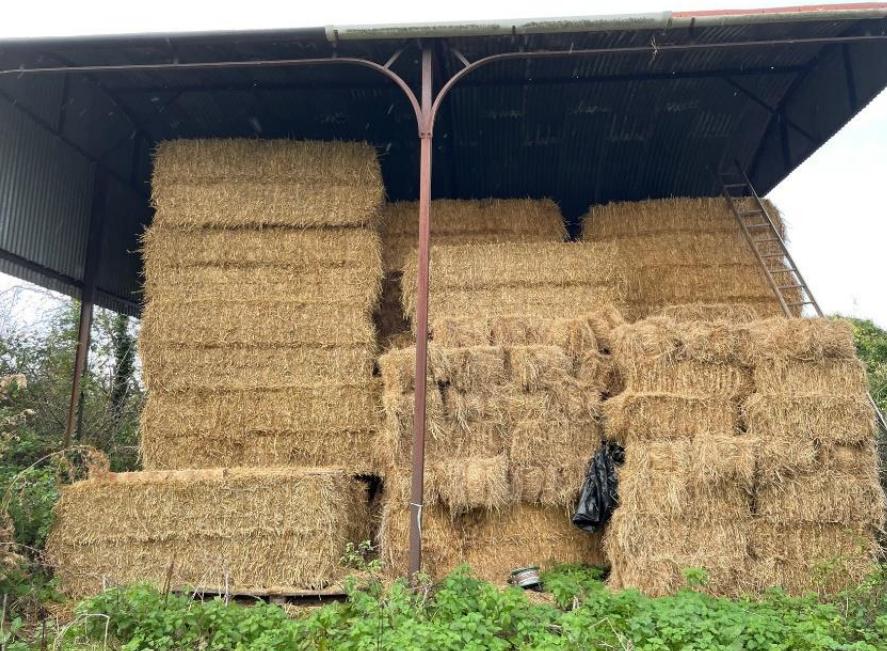
Feature	Type	Description	Date surveyed	Photos
		not record barn owl activity.		
PNS54	Hay bales in Dutch barn	<p>Stacked hay bales in Dutch barn complex, with lots of cavities and depressions amongst bales offering suitable protection, all thoroughly checked. No other suitable roosting or nesting features present.</p> <p>Kestrel feathers identified atop bales indicating roosting by this species.</p>	29/06/2021

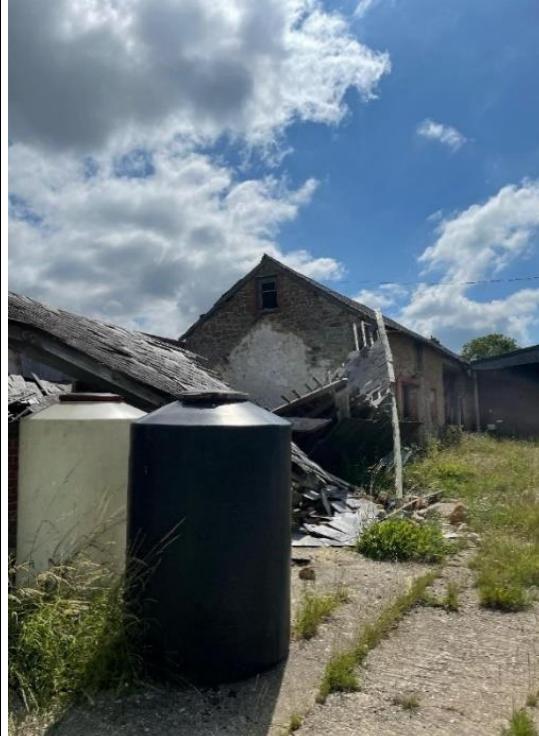
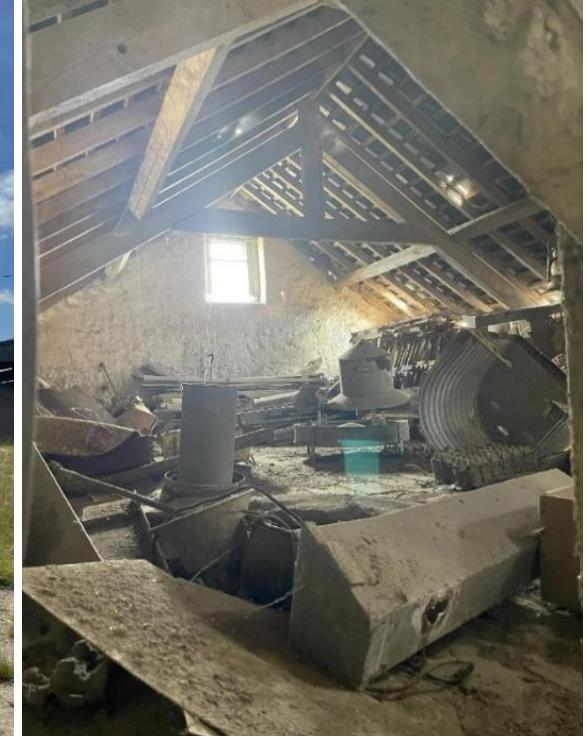
Feature	Type	Description	Date surveyed	Photos	
PNS55	Large unused barn	<p>Roof space of old stone barn, used for storage but seemingly not for a long time. Access is through window on northern aspect with missing glass.</p> <p>Potential to nest on floor amongst debris.</p> <p>Roosting opportunities on wooden beams.</p> <p>Old jackdaw nest including dead young identified in feature.</p>	15/07/2021

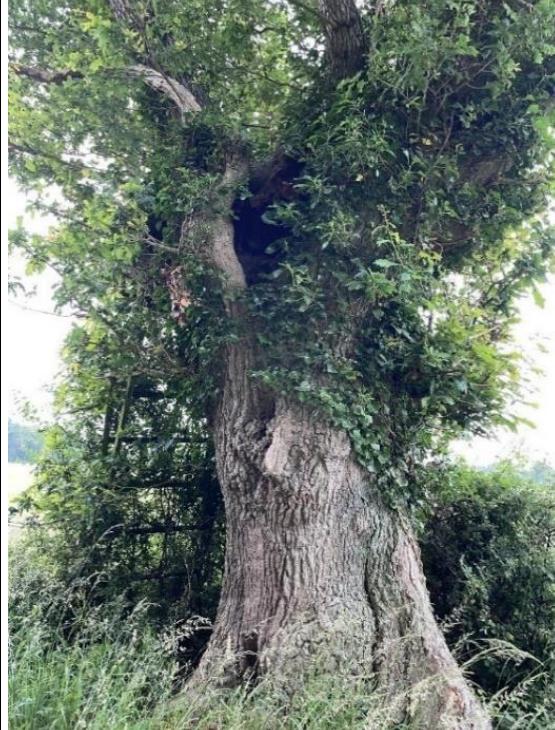
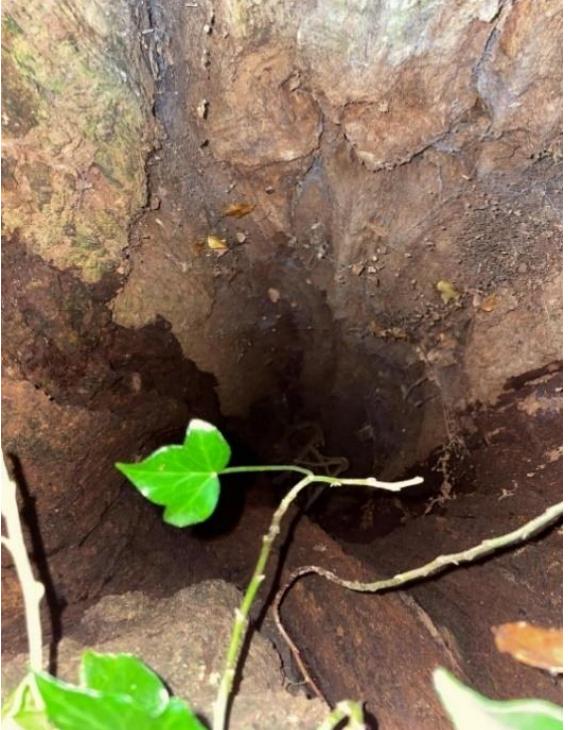
Feature	Type	Description	Date surveyed	Photos	
PNS56	Hollow oak on edge of woodland	<p>Huge cavity in oak caused by trunk fully rotting inside, down to ground level.</p> <p>Entrance hole from historic limb tear out at 3m height.</p> <p>Potentially too exposed to elements but precautionarily treated as PNS.</p>	29/06/2021

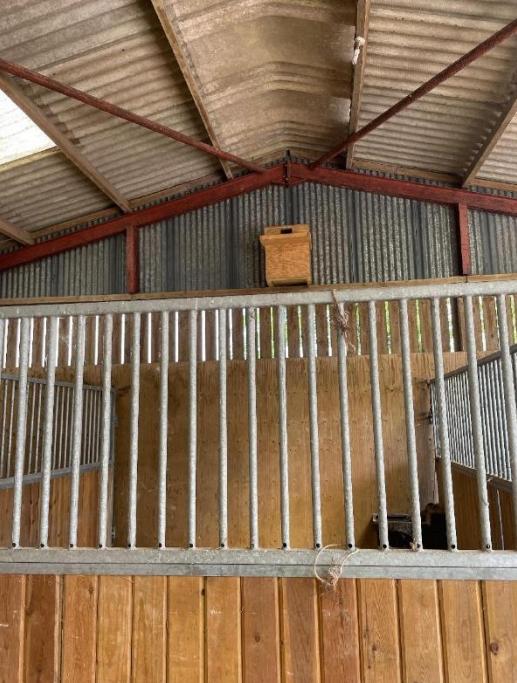
Feature	Type	Description	Date surveyed	Photos
PNS57	Purpose built nest box in modern agricultural building	<p>Wooden nest box in good condition. Landowner report erecting several years before but has not seen barn owl utilise it.</p> <p>Occupied by nesting jackdaw at the time of survey.</p>	09/06/2021

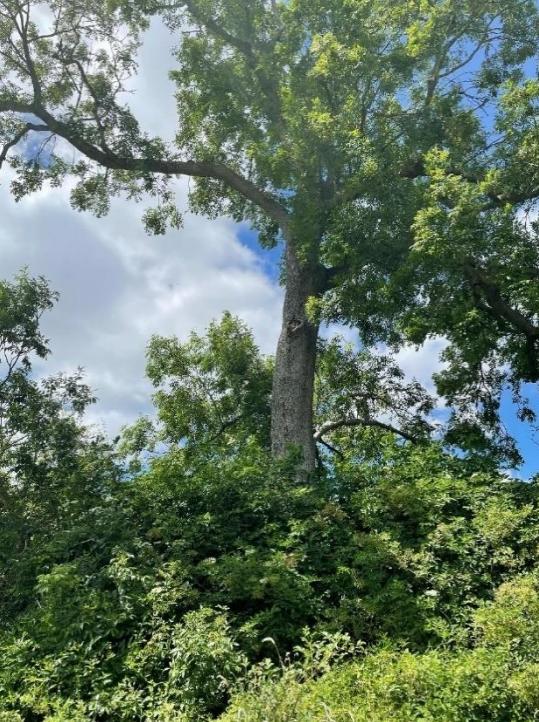
Feature	Type	Description	Date surveyed	Photos
PNS58	Cavity in ash tree	Apparent cavity high in trunk of mature ash. Cavity not reachable due to height and dense scrub surrounding base of the tree.	15/07/2021

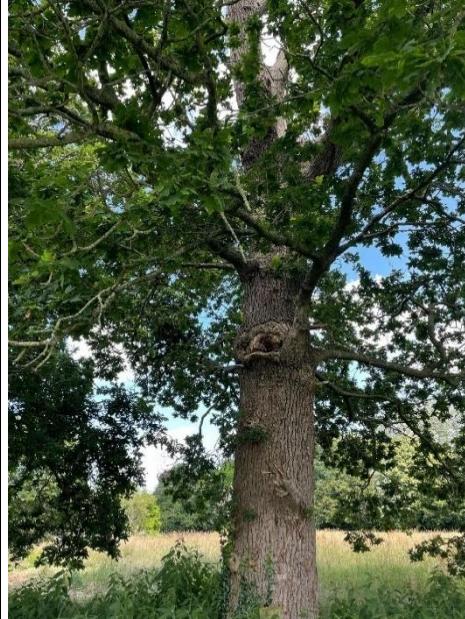
Feature	Type	Description	Date surveyed	Photos
PNS61	Cavity in standard oak tree	<p>Apparent cavity in trunk of oak, caused from limb tear out. Considerable heartwood visible in tear out but a small entrance into a potential cavity is visible.</p> <p>Feature not inspected internally as could not be safely reached with ladders.</p>	15/07/2021

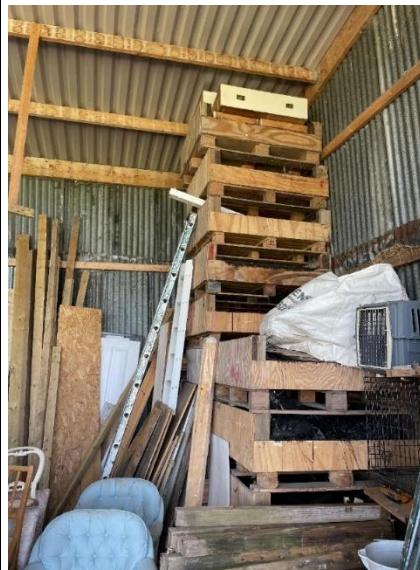
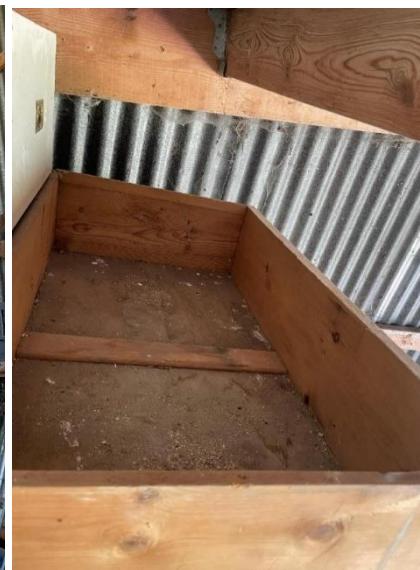
PNS62	Tray formed by stacked pallets	<p>Flat enclosed surface in modern barn created by stacked pallets with cupboard draws on top. 6m high.</p> <p>Feature is not permanent but landowner notes that they have been in this position for a number of years.</p>	08/06/2021

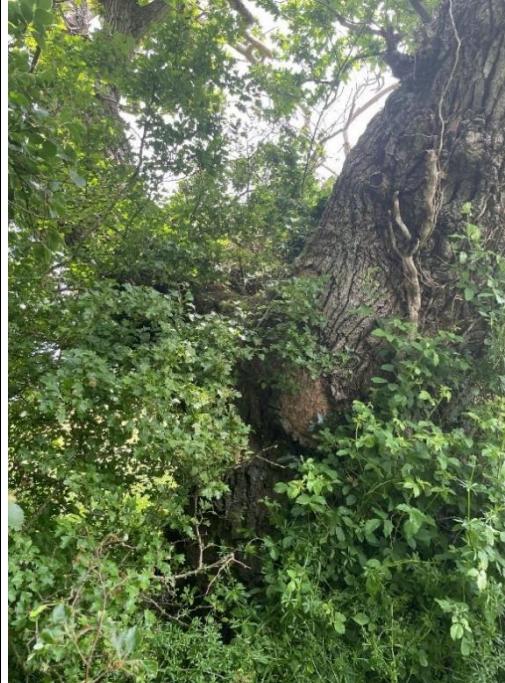
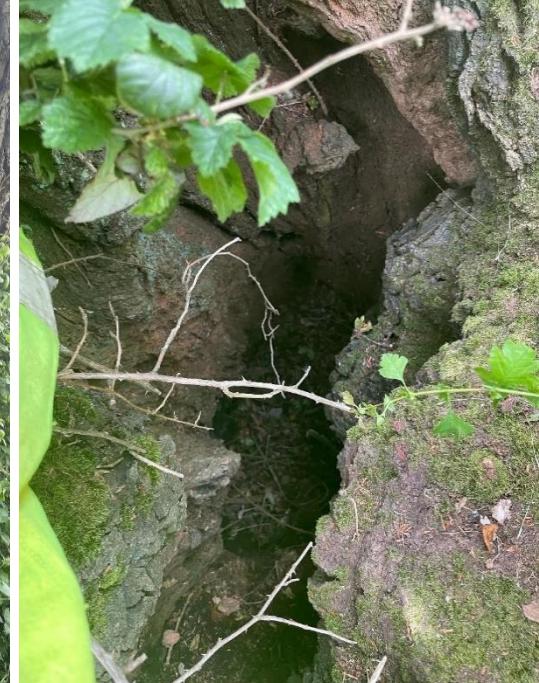
Feature	Type	Description	Date surveyed	Photos
PNS63	Hollow oak tree	<p>Hollow trunk of squat veteran oak tree on field edge. Cavity formed by trunk rotting down to base, with entrance at 2.5m where the trunk branches. Somewhat obscured by the canopy.</p> <p>Cavity appears too exposed to the elements to be suitable for nesting barn owl but was dry at the time of survey. Precautionarily classified as PNS.</p>	09/08/2021

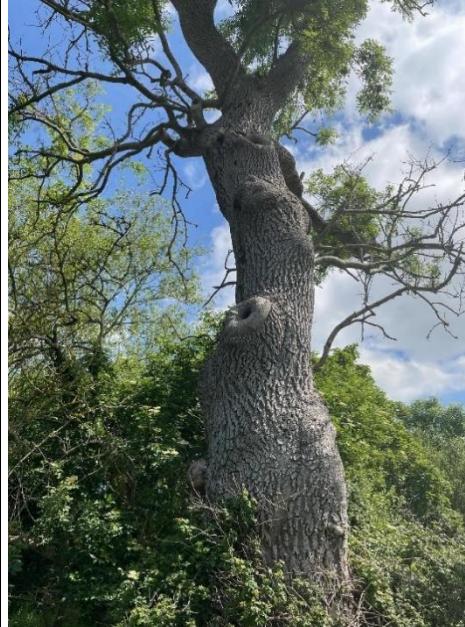
Feature	Type	Description	Date surveyed	Photos
PNS64	Cavities in ash tree	<p>Two cavities in mature ash tree adjacent to river. Lower cavity caused by knothole is not suitable, with too small an entrance and insufficient cavity size behind.</p> <p>Not possible to check higher cavity at approximately 8m as unsafe to do so.</p> <p>Cavity appears to be larger but also more exposed to the elements.</p> <p>Precautionarily treated as PNS.</p>	08/06/2021

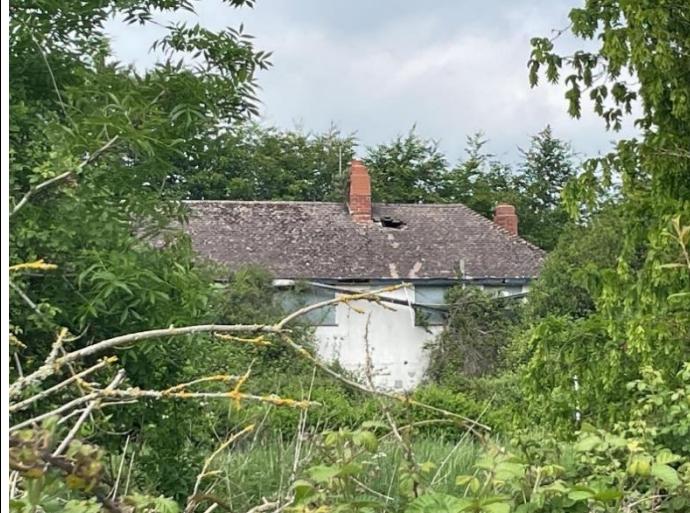
PNS65	Derelict residential property	<p>Modern residential property but has clearly been abandoned for many years. Multiple access points through gaps in roof tiles. Assumed multiple suitable nesting surfaces inside.</p>	09/06/2021 (with subsequent dusk emergence on 02/08/2021)

- 3.2.8 No barn owl activity was recorded during the dusk emergence undertaken on the two derelict buildings on 2 August 2021. These buildings were not, therefore, considered be an OBS, but still represent a PNS.

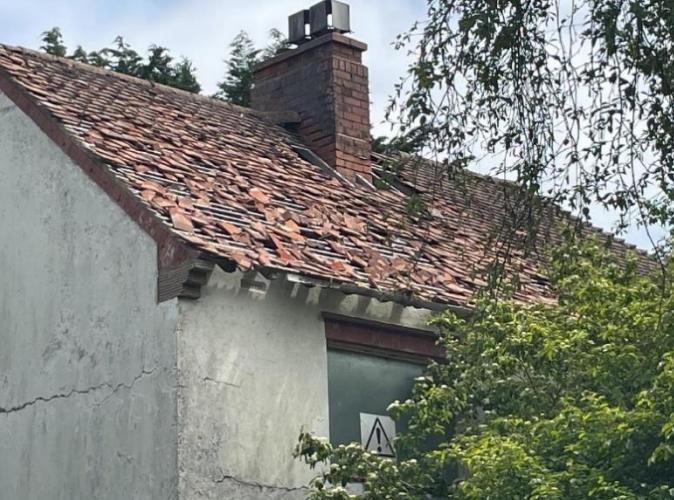
Feature	Type	Description	Date surveyed	Photos
PNS66	Derelict residential property	Modern residential property but has clearly been abandoned for many years. Multiple access points through gaps in roof tiles. Assumed multiple suitable nesting surfaces inside.	09/06/2021 (with subsequent dusk emergence on 02/08/2021)
