A358 Taunton to Southfields Dualling Scheme

Ecological Baseline Report - Otter

HE551508-ARP-EBD-ZZ-RP-LE-000016

24 May 2022

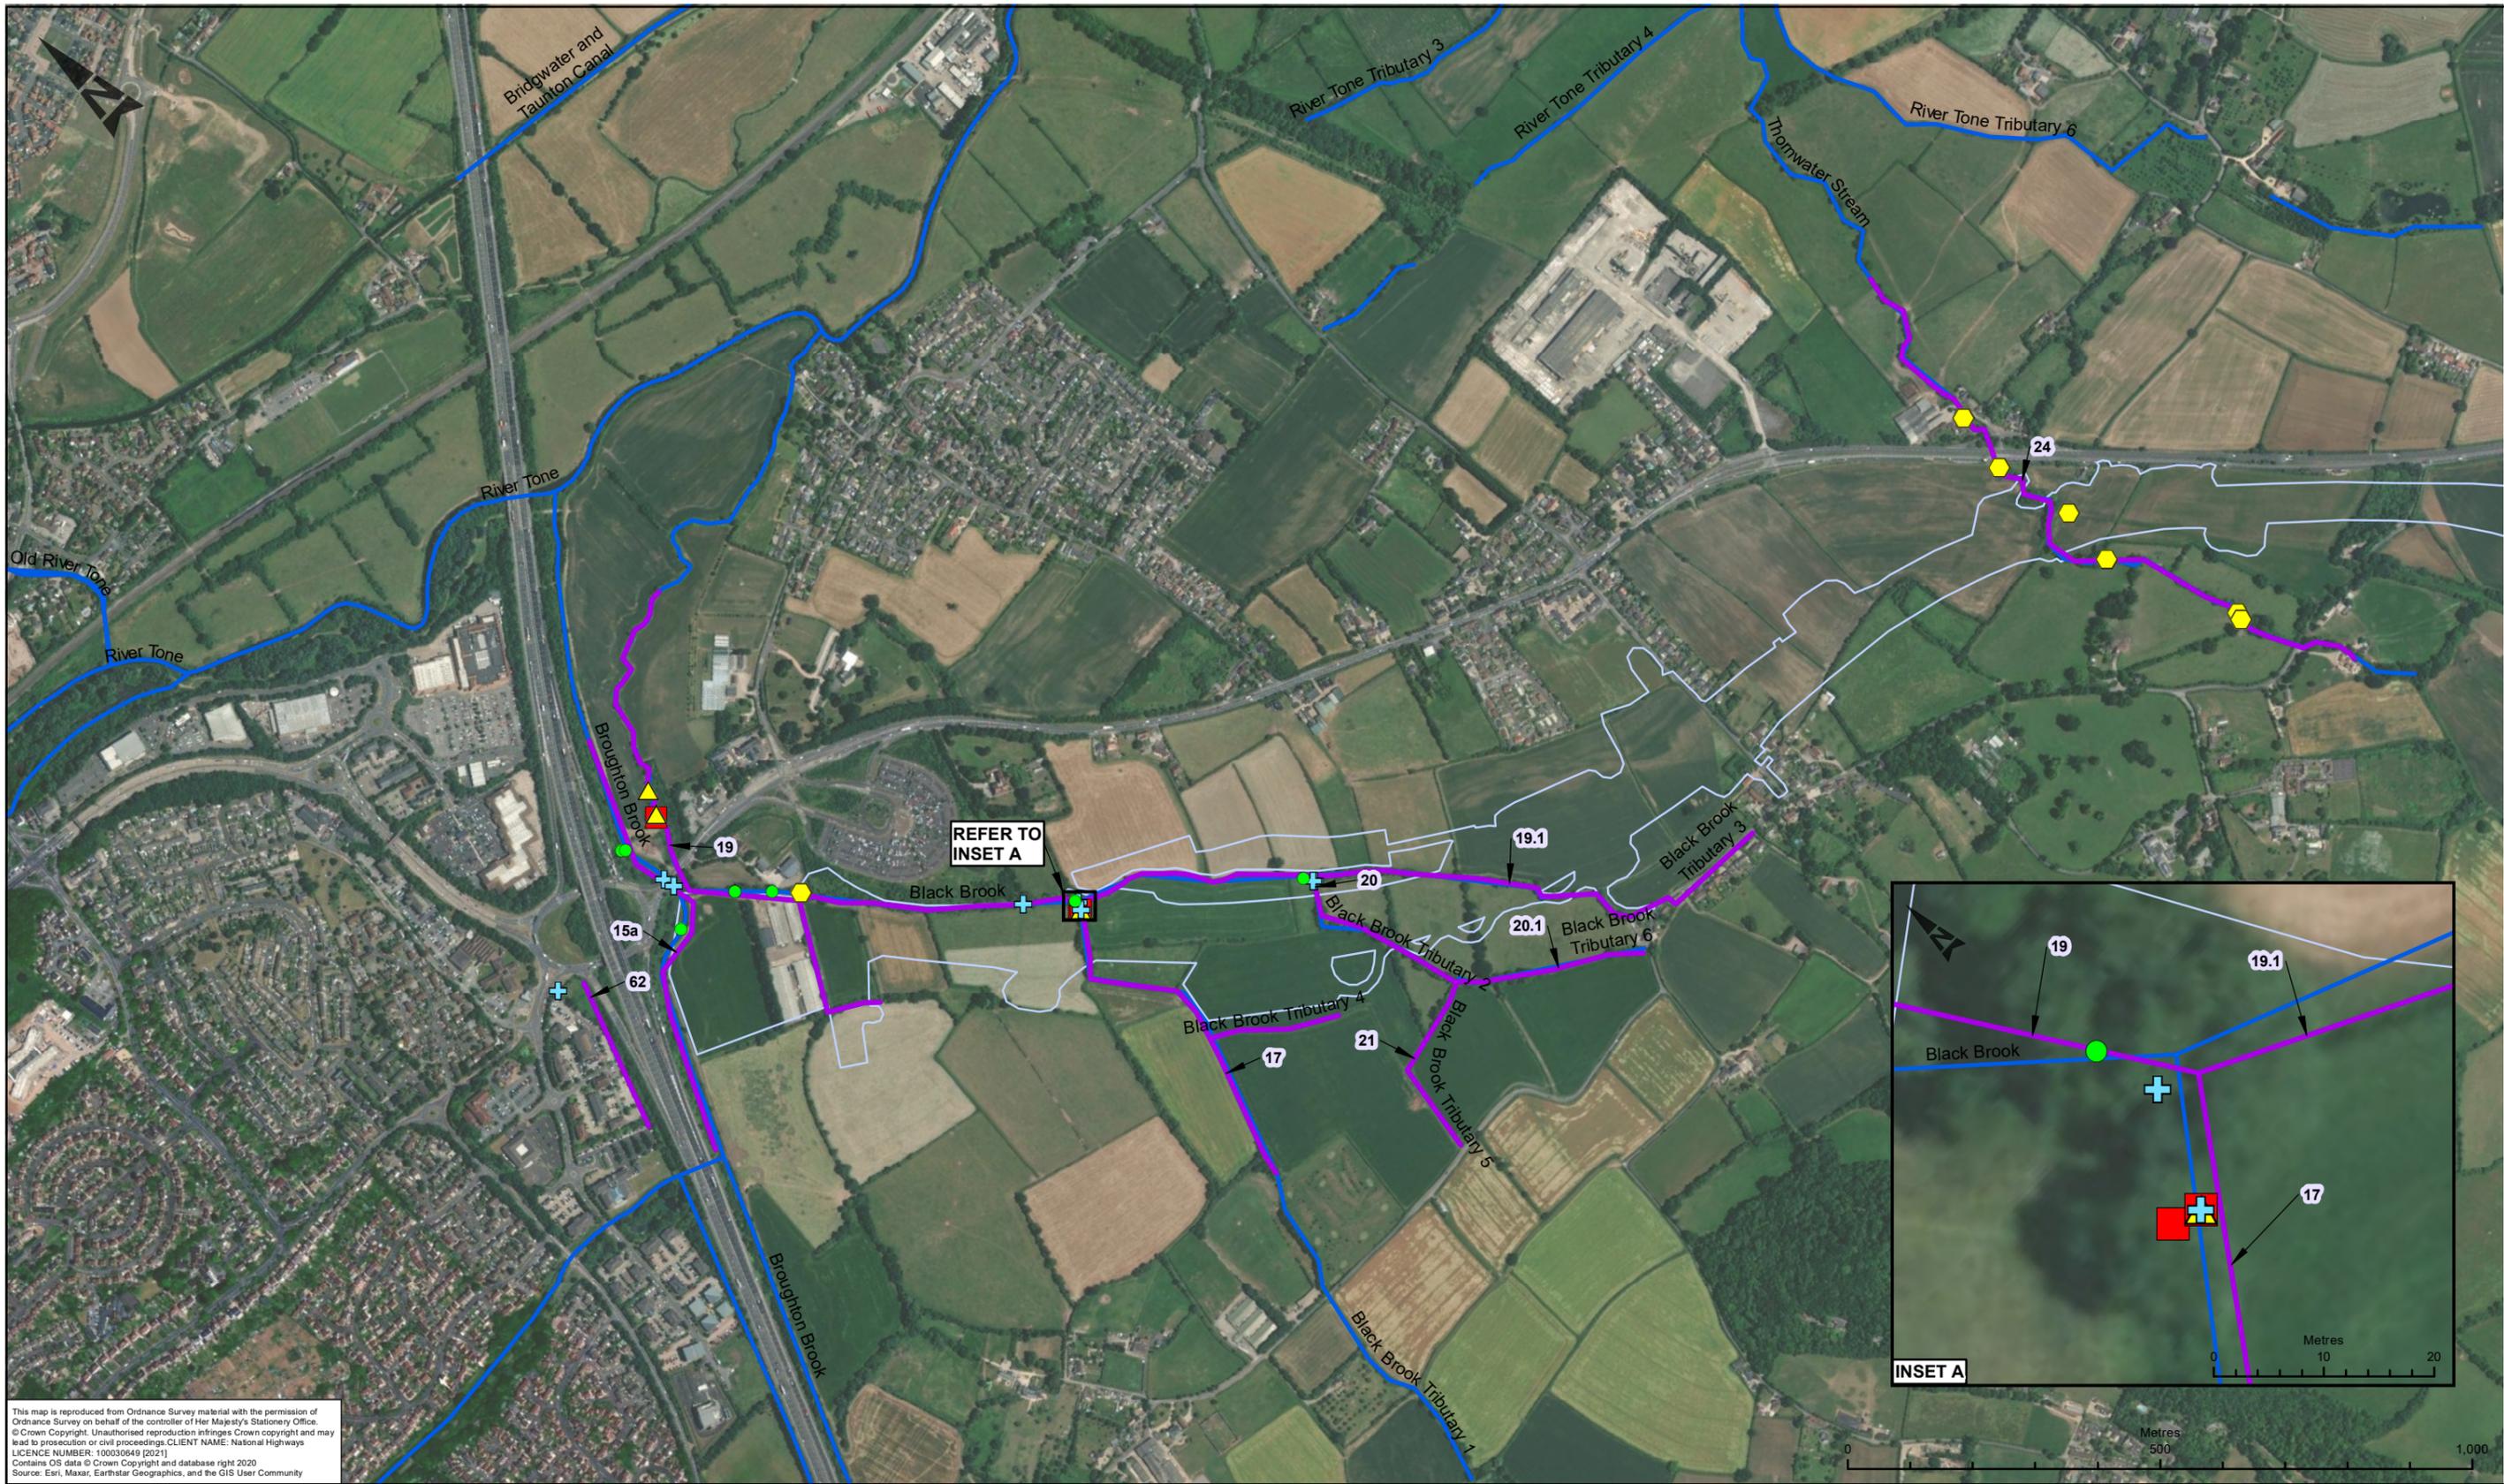
Appendix B Otter survey area and field signs

Project Title		A358 TAUNTON TO SOUTHFIELDS DUALLING SCHEME			
Drawing Title		OTTER SURVEY RESULTS SHEET 1 OF 4			
Scale	By	Checked	Approved	Authorised	
1:10,000	LL	MA	JS	SV	
Original Size	Date	Date	Date	Date	
A3	13/05/22	13/05/22	13/05/22	13/05/22	
Drawing Number	HE PIN	Originator	Volume	Revision	
HE551508 - ZZ	ZZ	ARP - DR	VES - LE	P02	
Location	Type	Role	Number

3.3.1 22 out of the 23 watercourses subject to the habitat suitability assessment were deemed suitable (low to high suitability) for supporting otter. Watercourse 32 was found to be unsuitable for otter during the initial habitat assessment and was therefore scoped-out of the remaining surveys. The 22 suitable watercourses were all then subject to detailed otter field signs surveys. Positive field signs of otter were recorded on 15 watercourses. Field signs were located directly underneath the A348 at various bridges and culvert locations, as well as up to 500 metres upstream and downstream of the scheme.
