Current layout

Option A

Option B

Option C

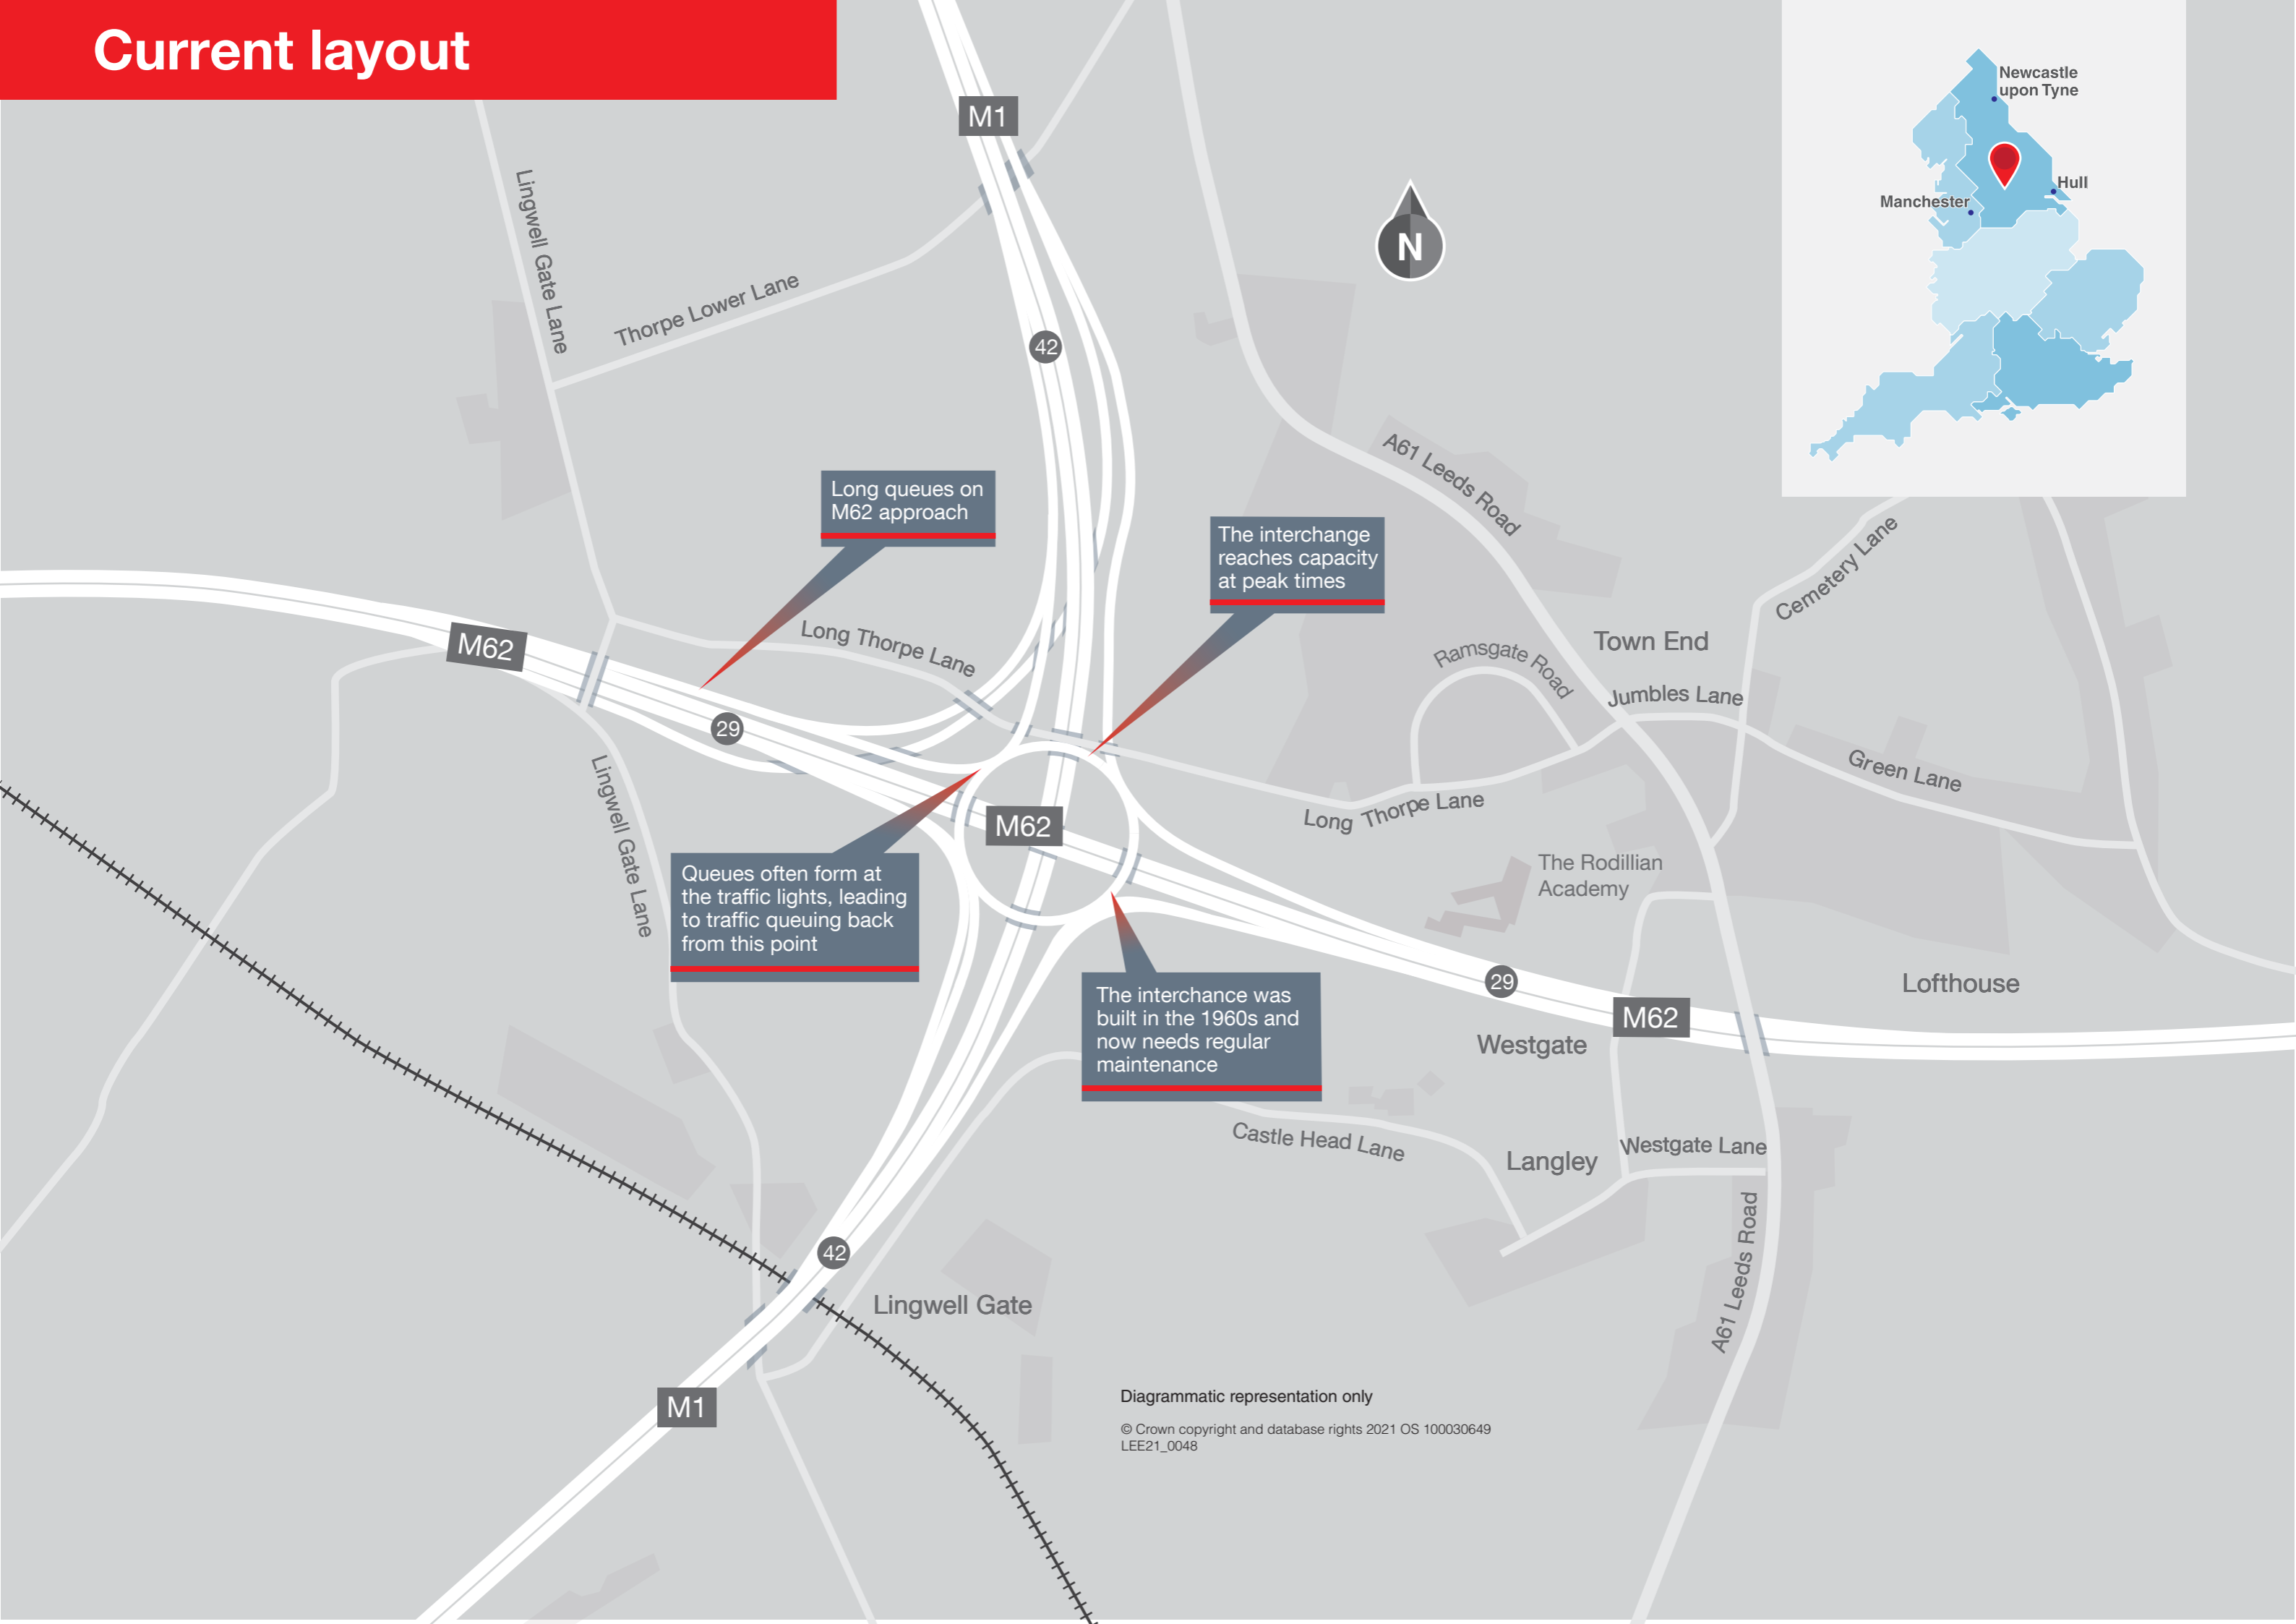
Long queues on M62 approach

The interchange reaches capacity at peak times

Queues often form at the traffic lights, leading to traffic queuing back from this point

The interchange was built in the 1960s and now needs regular maintenance

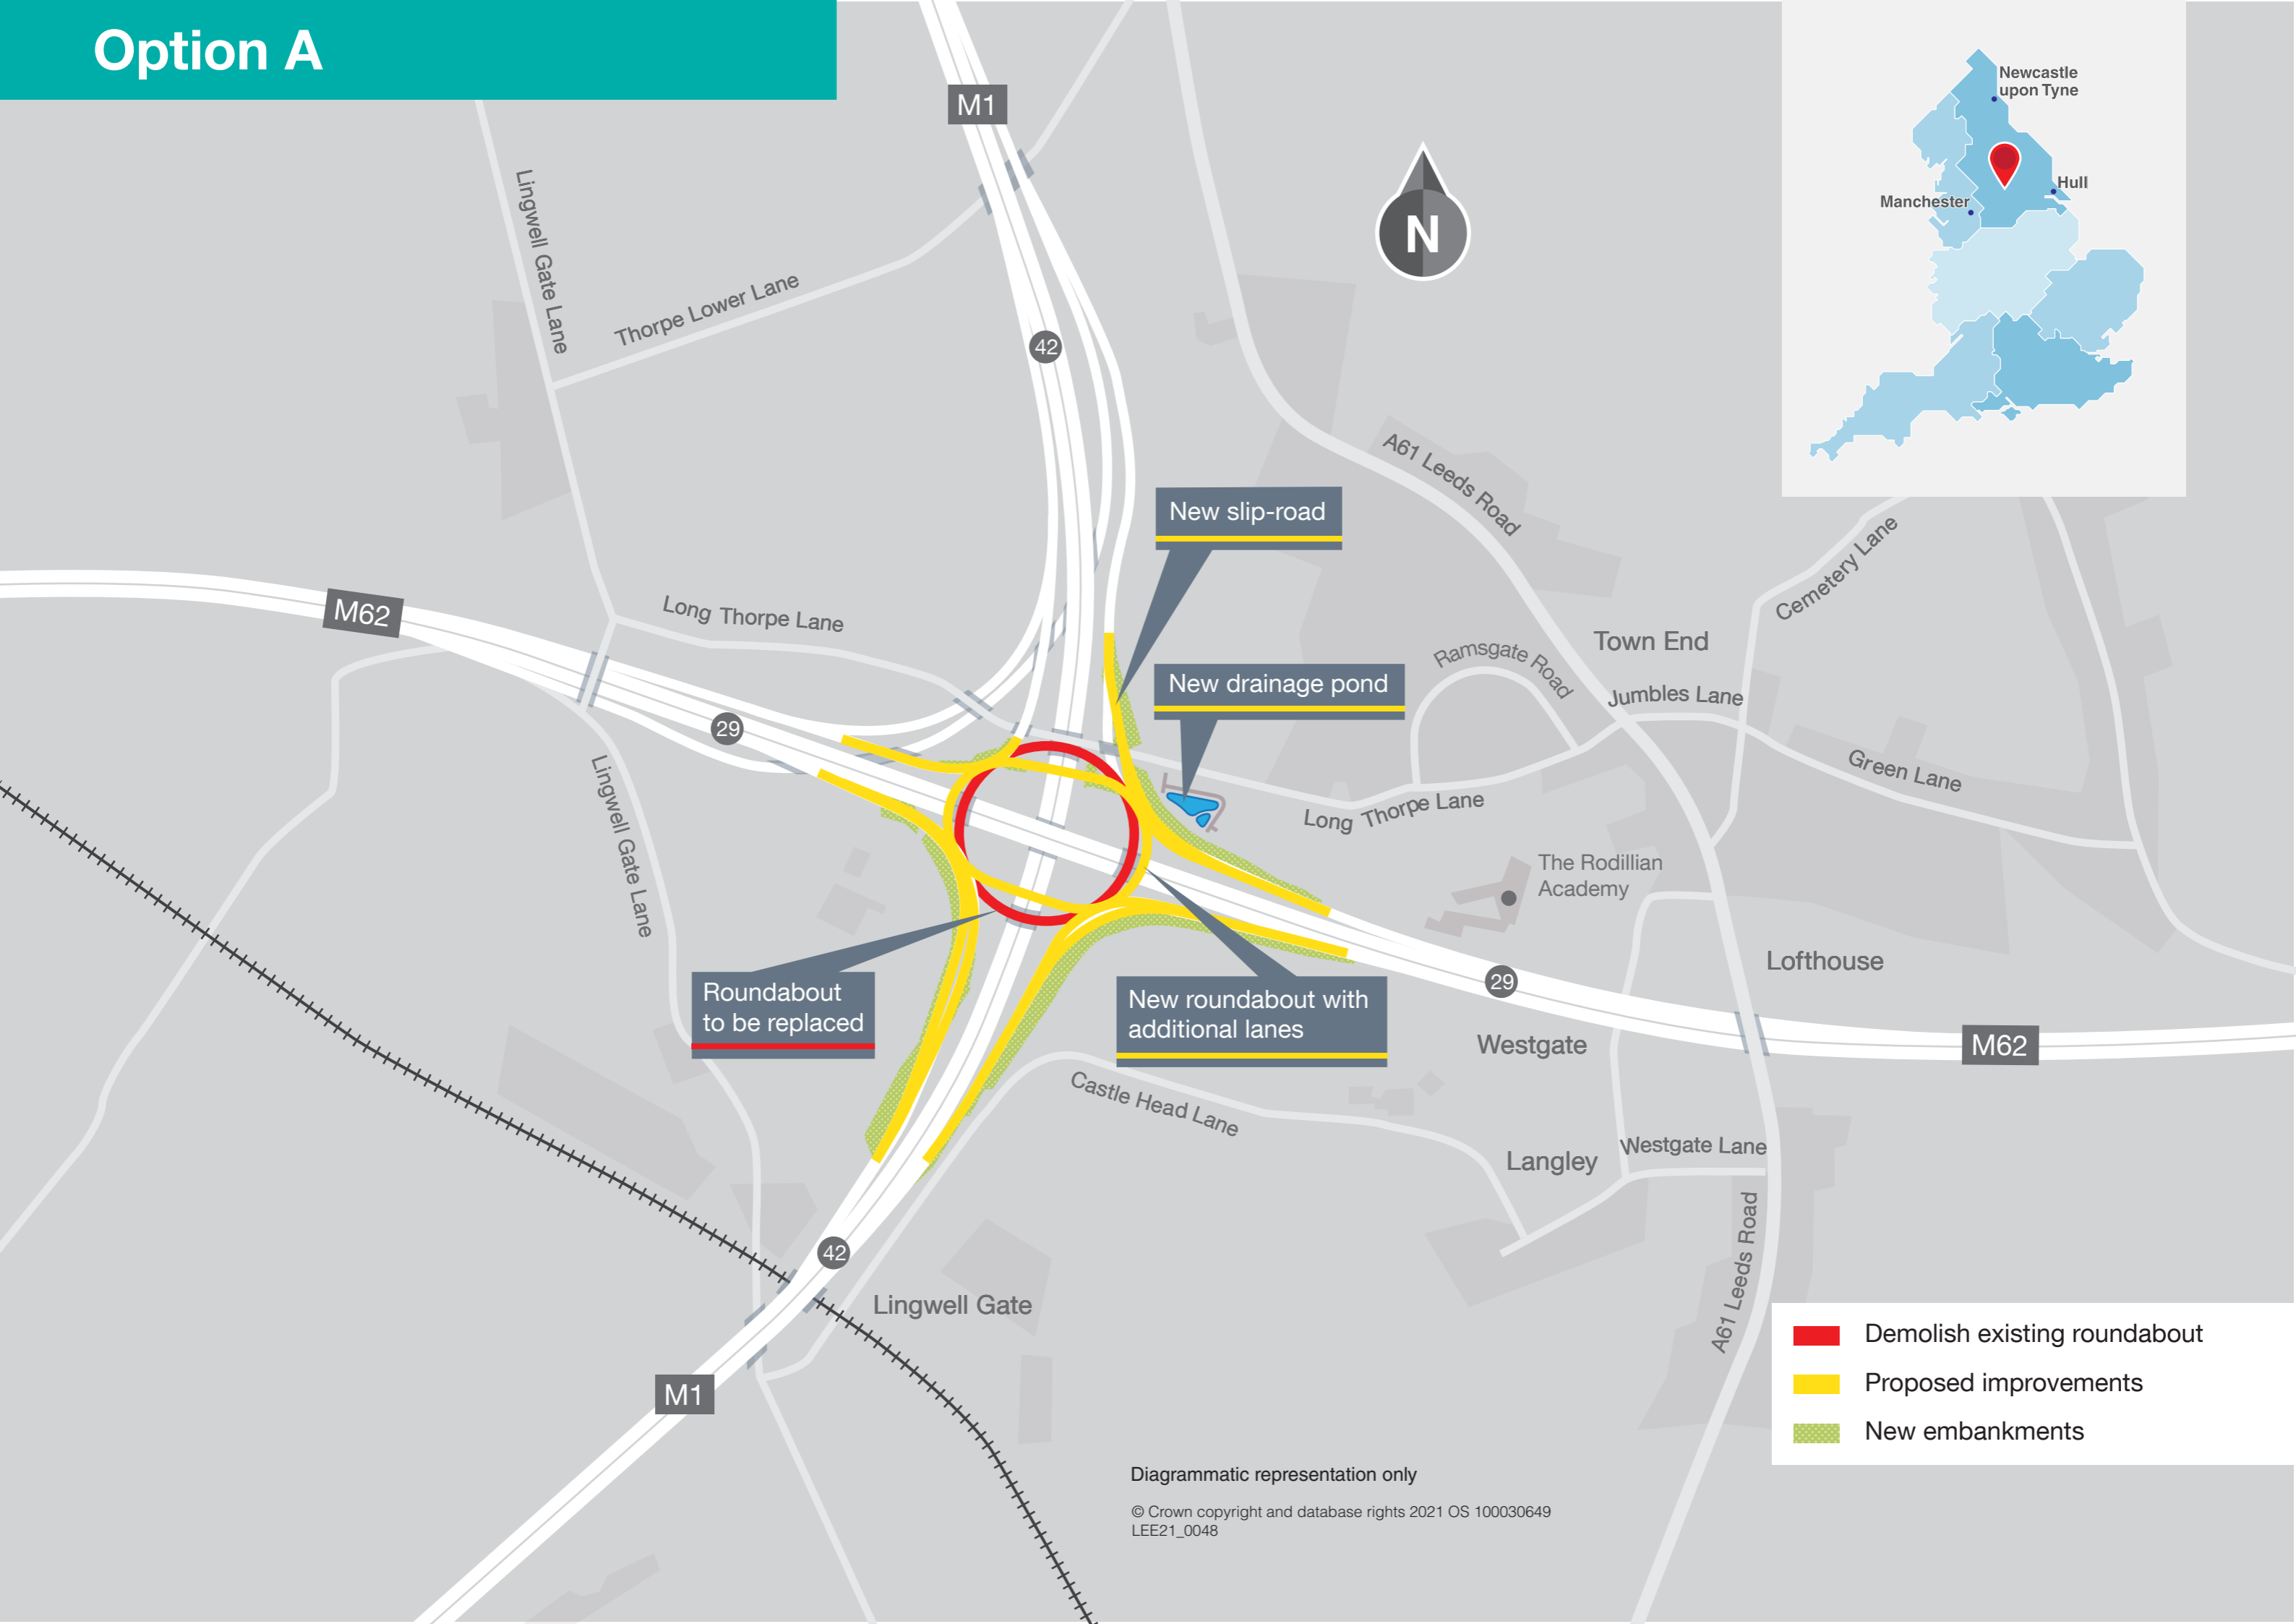
Roundabout to be replaced

New slip-road

New drainage pond

New roundabout with additional lanes

Demolish existing roundabout
-

Proposed improvements
-

New embankments

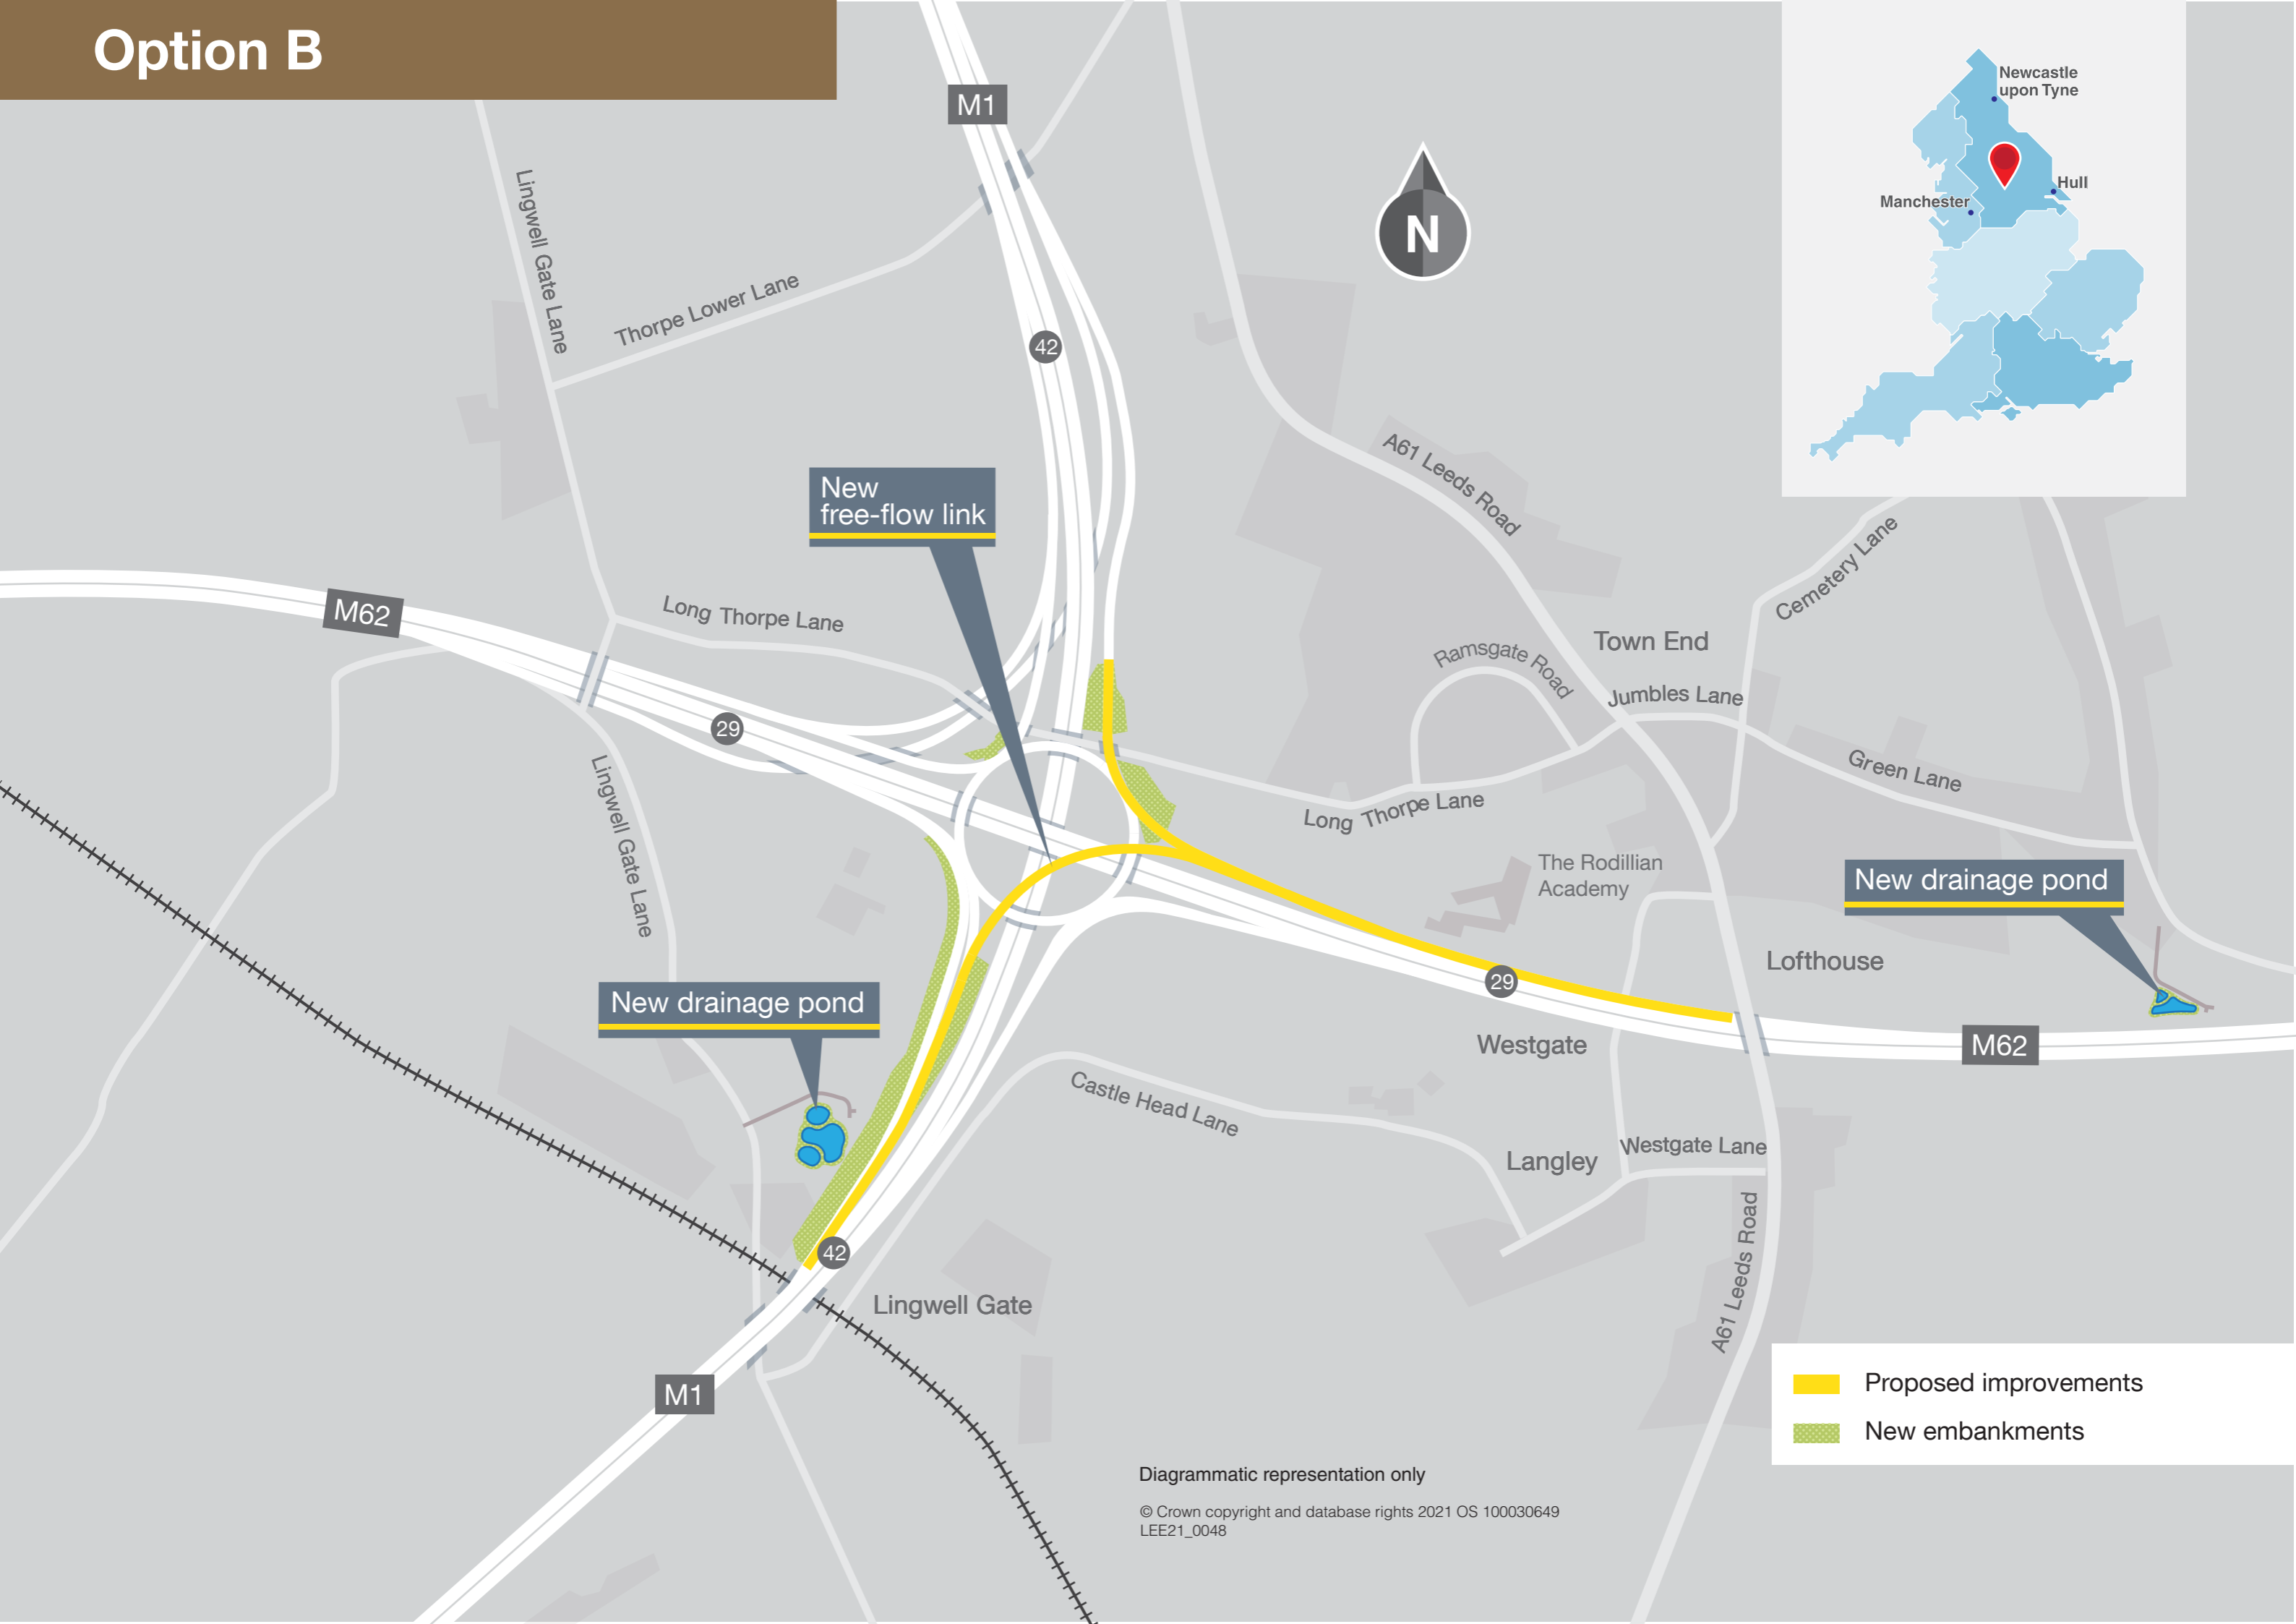
New free-flow link

New drainage pond

- Proposed improvements
- New embankments

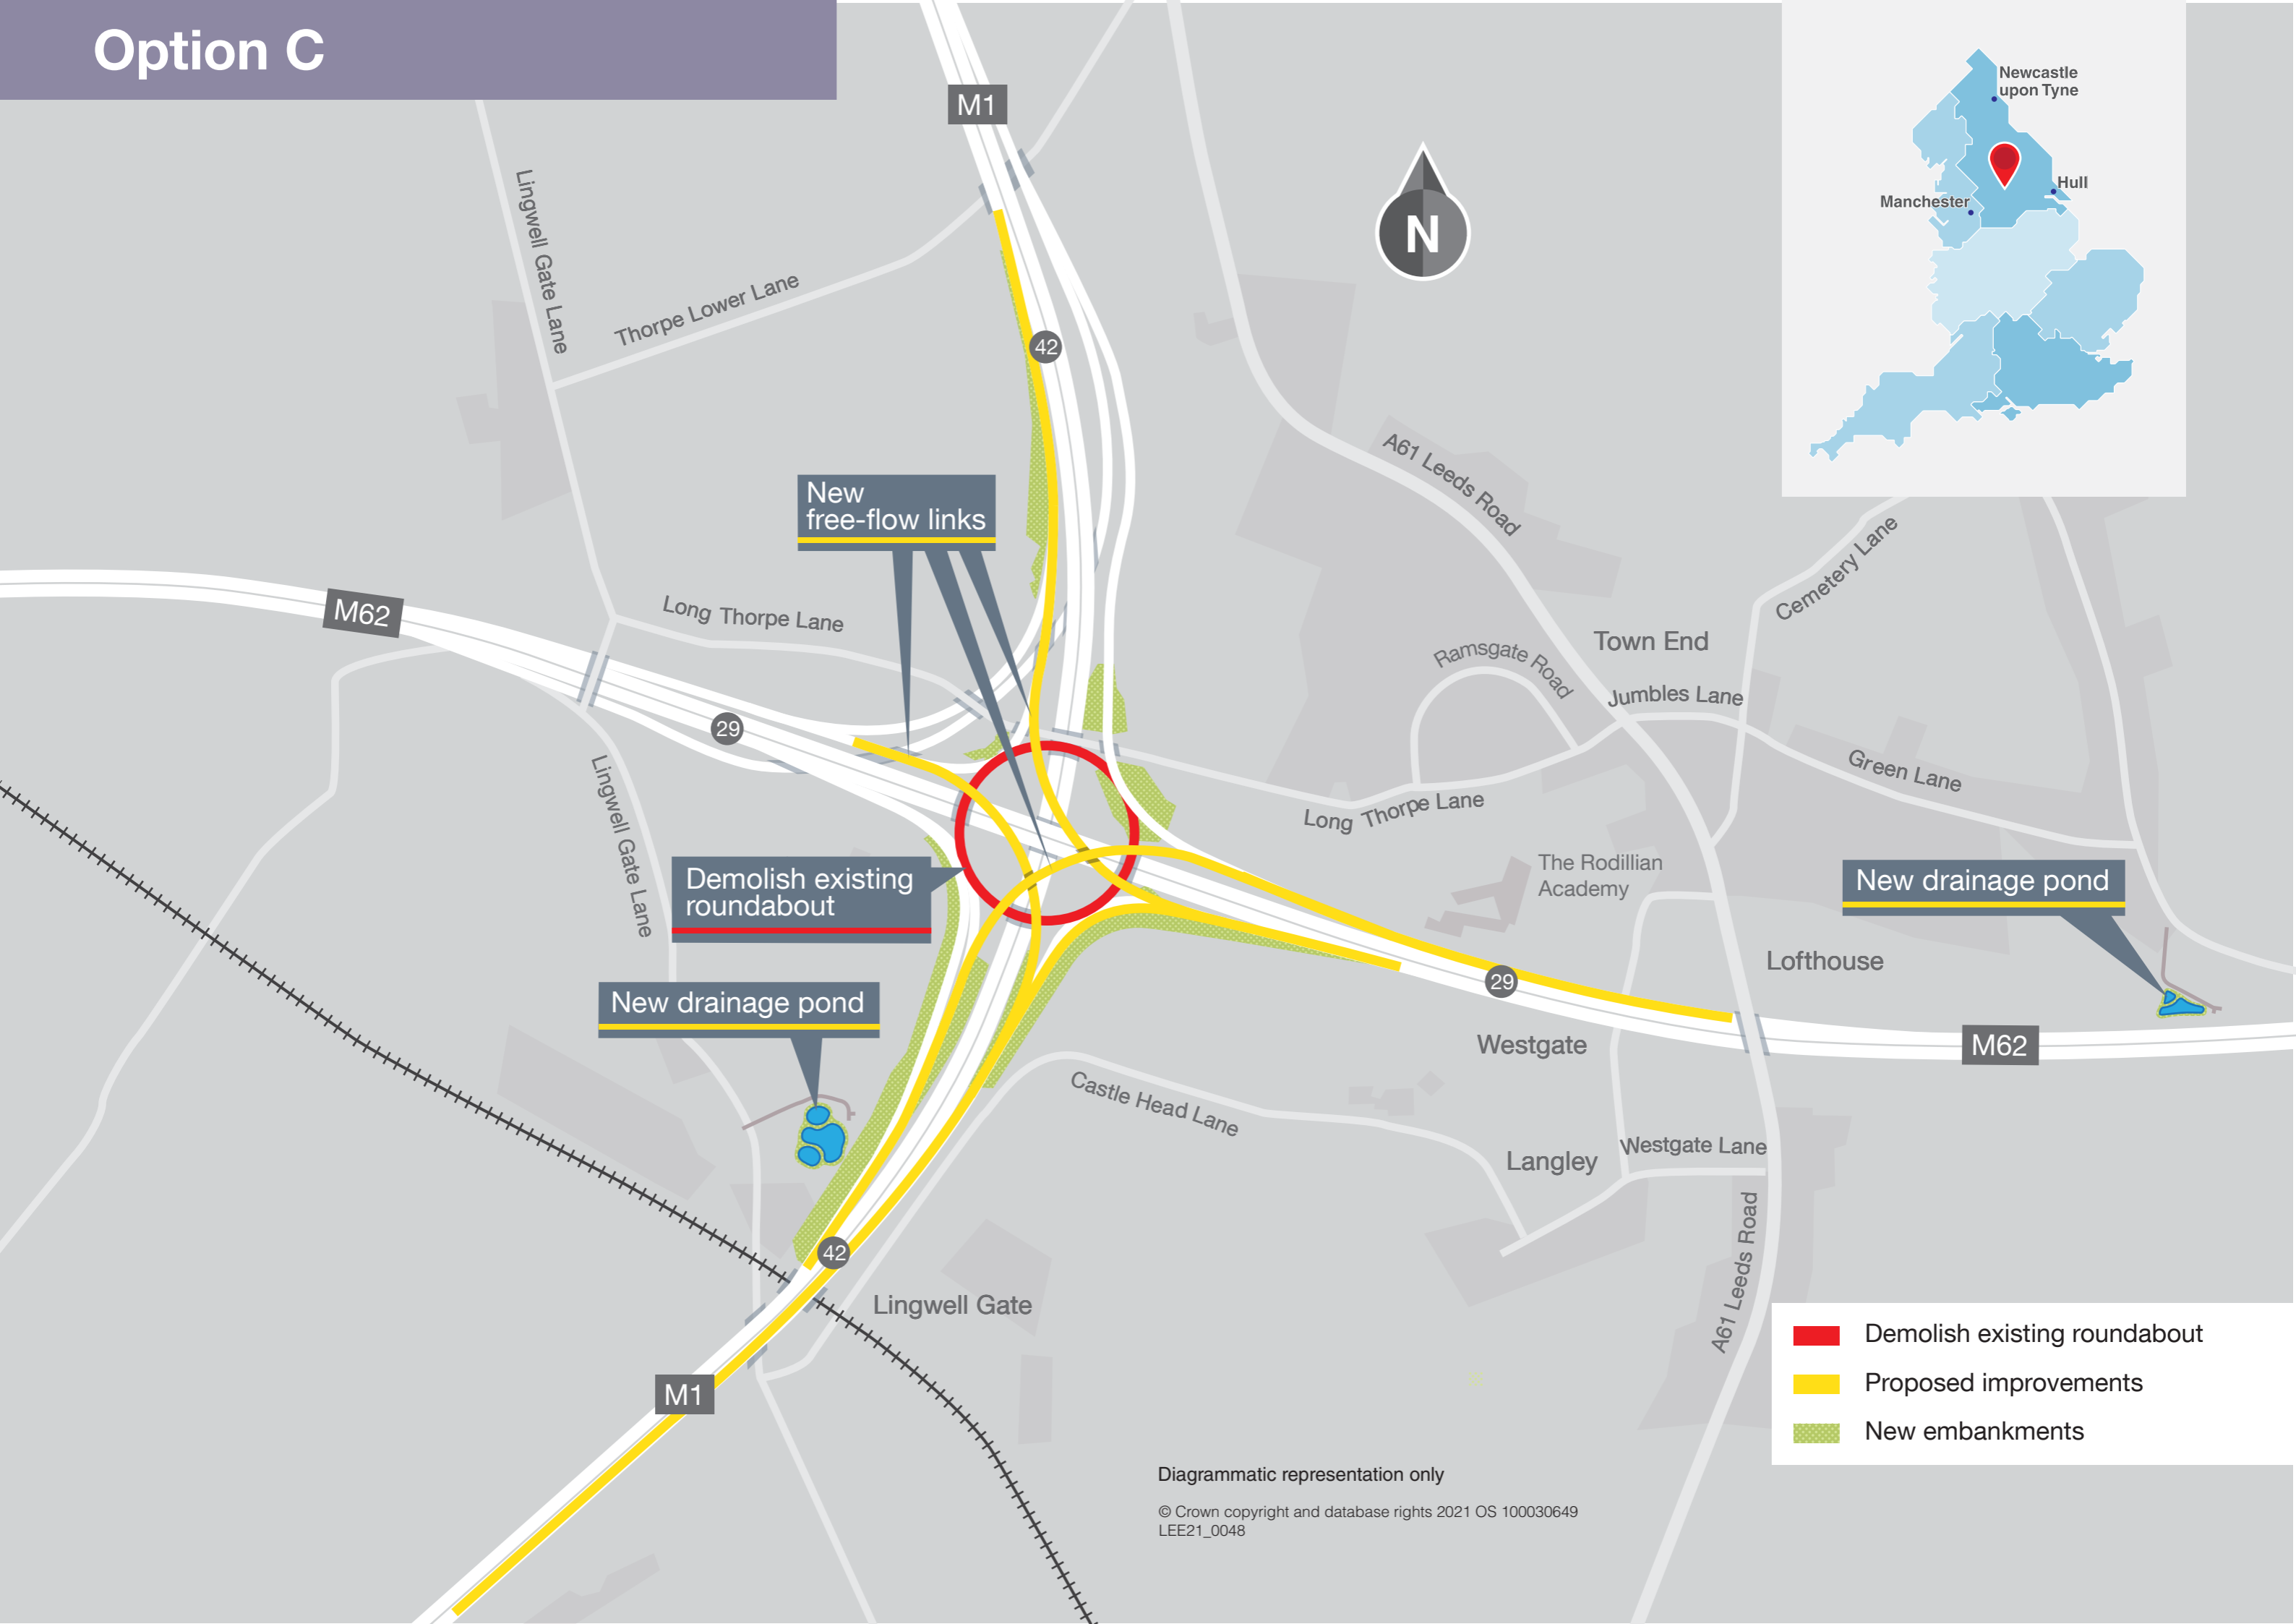
Demolish existing roundabout
-

Proposed improvements
-

New embankments
